AIRPROX REPORT No 2021023

Date: 12 Apr 2021 Time: 1354Z Position: 5141N 00133W Location: 4NM S Witney

PART A: SUMMARY OF INFORMATION REPORTED TO UKAB

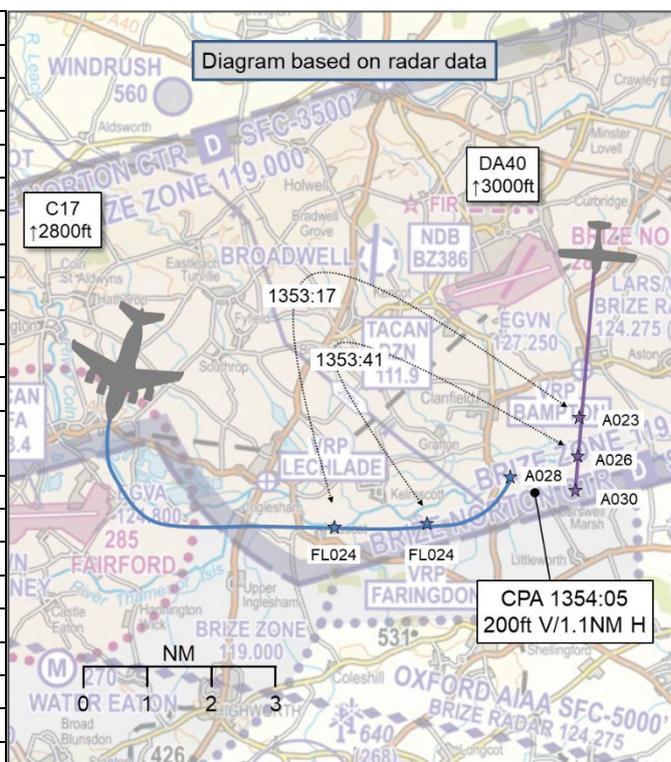
Recorded	Aircraft 1	Aircraft 2
Aircraft	C17	DA40
Operator	HQ Air (Ops)	Civ FW
Airspace	Brize CTR	Brize CTR
Class	D	D
Rules	IFR	VFR
Service	Radar Control	Radar Control
Provider	Brize Director	Brize Radar
Altitude/FL	2800ft	3000ft
Transponder	A, C, S	A, C,S
Reported		
Colours	Standard C17	White
Lighting	Nav, Strobes, Landing	Nav, Strobes
Conditions	VMC	VMC
Visibility	NR	NR
Altitude/FL	2800ft	2400ft
Altimeter	QNH	QNH
Heading	080°	180°
Speed	NK	110kt
ACAS/TAS	TCAS II	Unknown
Alert	TA	Unknown
Separation		
Reported	0ft V/4000ft H	200ft V/0.5-1NM H
Recorded	200ft V/1.1NM H
