## AIRPROX REPORT No 2021036

Date: 22 Apr 2021 Time: 1128Z Position: 5108N 00015E Location: Tunbridge Wells

### PART A: SUMMARY OF INFORMATION REPORTED TO UKAB

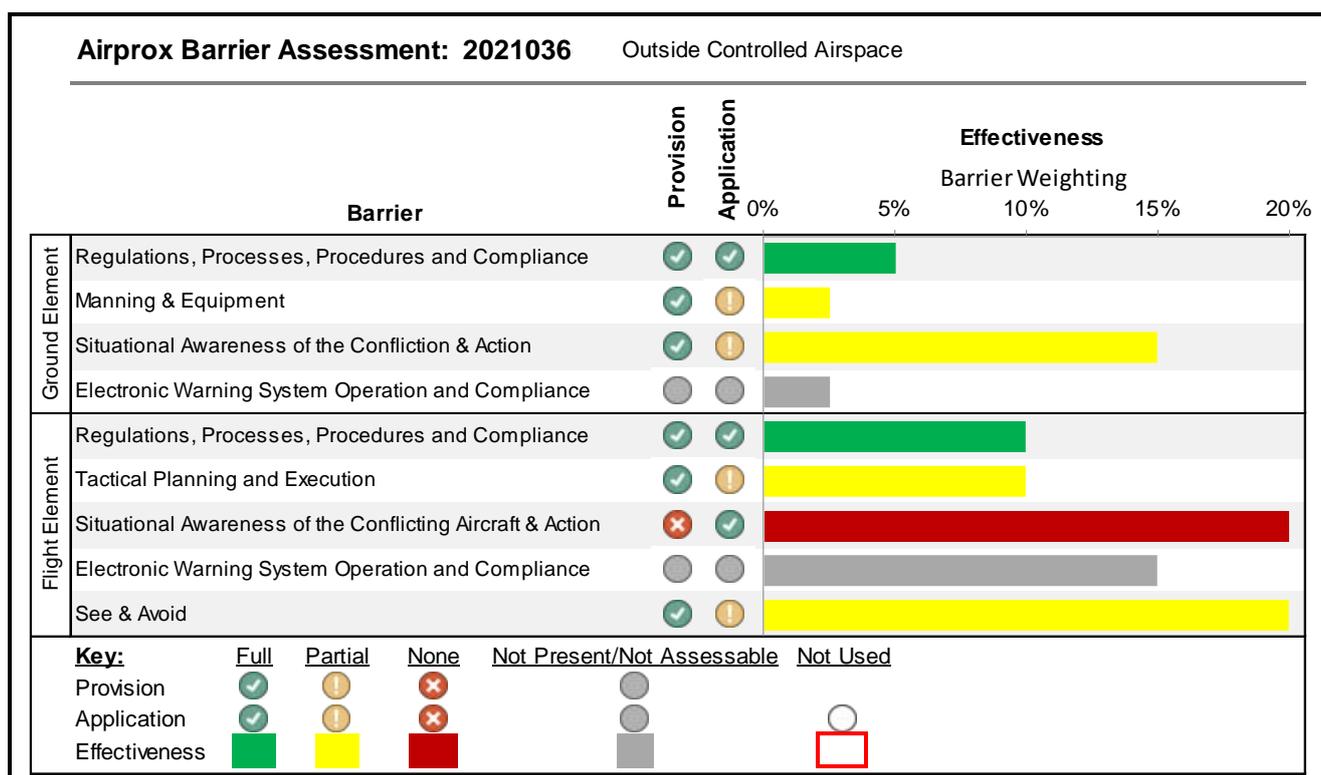
**Situational Awareness of the Conflicting Aircraft and Action** were assessed as **ineffective** because neither pilot had any situational awareness of the presence of the other aircraft prior to sighting it.

**See and Avoid** were assessed as **partially effective** because the PA28(A) pilot sighted PA28(B) at a late stage and had to take immediate avoiding action, and the PA28(B) pilot did not see PA28(A) until at or around CPA.
