**AIRPROX REPORT No 2021048**

Date: 02 May 2021 Time: 1332Z Position: 5158N 00121W Location: IVO Barford St John

**PART A: SUMMARY OF INFORMATION REPORTED TO UKAB**

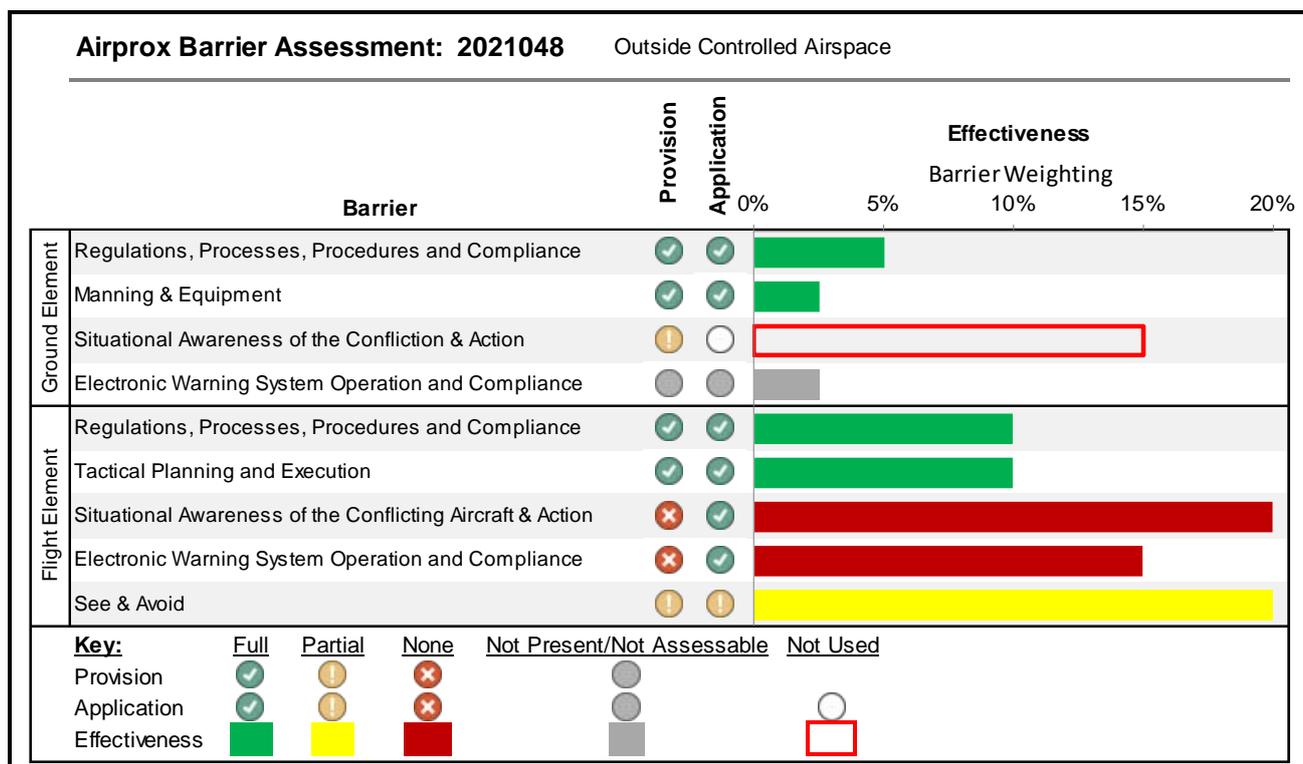
**Electronic Warning System Operation and Compliance** were assessed as **ineffective** because the FLARM on the glider could not detect the DA40 and the TAS on the DA40 could not detect the glider.

**See and Avoid** were assessed as **partially effective** because although it was a late sighting, the DA40 pilot managed to take avoiding action.
