AIRPROX REPORT No 2021105

Date: 11 Jul 2021 Time: 1010Z Position: 5112N 00113W Location: Popham Airfield

PART A: SUMMARY OF INFORMATION REPORTED TO UKAB

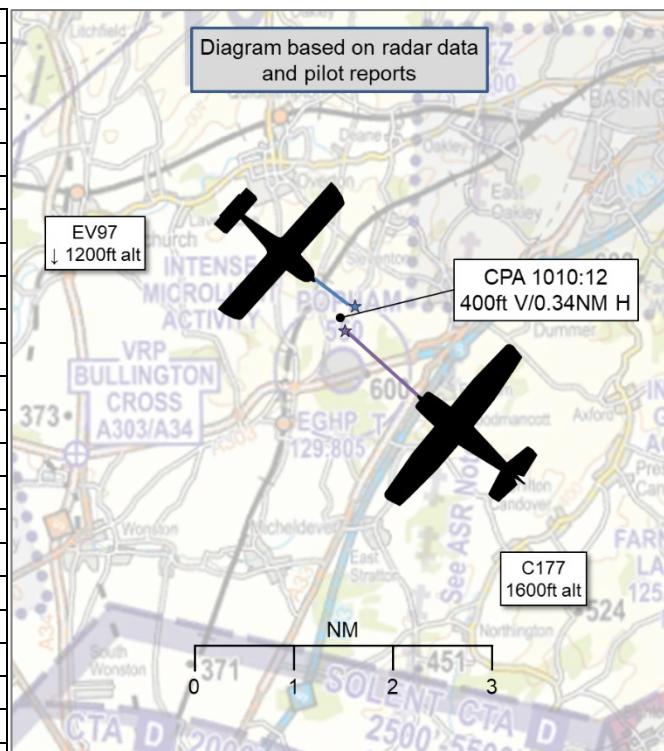
Recorded	Aircraft 1	Aircraft 2
Aircraft	EV97	C177
Operator	Civ FW	Civ FW
Airspace	London FIR	London FIR
Class	G	G
Rules	VFR	VFR
Service	AGCS	Basic
Provider	Popham	Solent/Farnborough
Altitude/FL	1200ft alt	1600ft alt
Transponder	A, C, S	A, C, S
Reported		
Colours	Silver	Blue, White
Lighting	None	Strobe, Landing
Conditions	VMC	VMC
Visibility	5-10km	5-10km
Altitude/FL	800ft agl	1600ft
Altimeter	QFE (997hPa)	QNH (NK hPa)
Heading	210°	350°
Speed	60kt	128kt
ACAS/TAS	Not fitted	SkyEcho
Alert	N/A	Information
Separation		
Reported	0m V/200m H	0ft V/NK H
Recorded		400ft V/0.34NM H

THE EV97 PILOT reports that they were on a glide approach and turning final in the circuit at Popham. Their passenger spotted an aircraft crossing from the dead-side at circuit height and at the upwind end of the RW. They turned slightly to pass behind the other aircraft and continued their approach. They called Popham radio to ask if the other pilot was in communication with them and they confirmed not. The aircraft crossed from the southeast to the northwest then turned north. They were using RW21 and the circuit was active. They feel that, although there was low cloud, flying through the overhead of an active circuit at circuit height with no communication was unacceptable, particularly when Popham has a busy flying school.
