AIRPROX REPORT No 2021118

Date: 16 Jul 2021 Time: 1202Z Position: 5147N 00119W Location: 4NM NW of Oxford

PART A: SUMMARY OF INFORMATION REPORTED TO UKAB

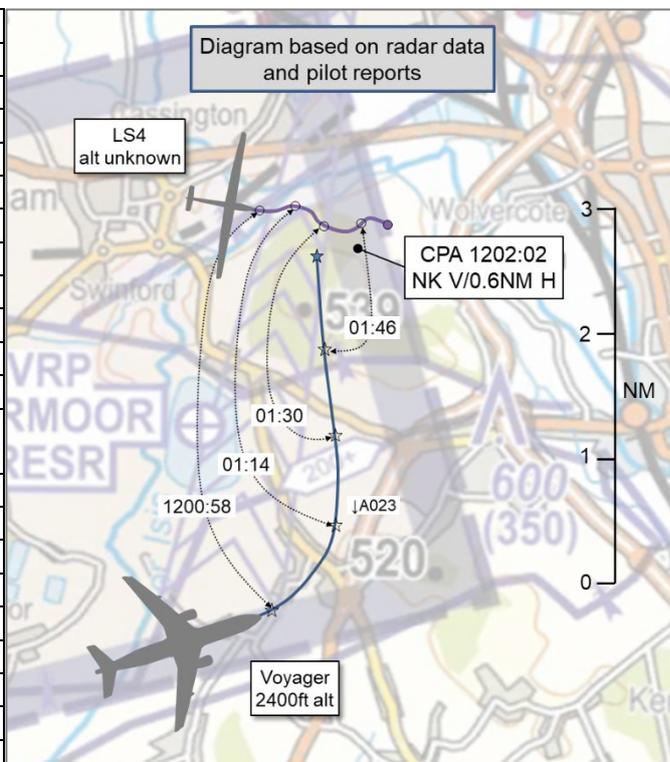
Recorded	Aircraft 1	Aircraft 2
Aircraft	Voyager	LS4
Operator	HQ Air (Ops)	Civ Glid
Airspace	Brize Norton CTR	Brize Norton CTR
Class	D	D
Rules	IFR	VFR
Service	Radar Control	None
Provider	Brize Director	N/A
Altitude/FL	A023	NK
Transponder	A, C, S	Not fitted
Reported		
Colours	Grey	White, red
Lighting	Strobes, beacon, nav, landing lights	N/A
Conditions	VMC	VMC
Visibility	>10km	5-10km
Altitude/FL	NR	2500ft
Altimeter	QNH (1027hPa)	QNH (NK hPa)
Heading	340°	180°
Speed	174kt	50kt
ACAS/TAS	TCAS II	FLARM
Alert	None	None
Separation		
Reported	0ft V/400-500m H	750ft V/500m H
Recorded	NK V/0.6NM H
