AIRPROX REPORT No 2021121

Date: 19 Jul 2021 Time: 1044Z Position: 5253N 00045W Location: ivo Belvoir Castle

PART A: SUMMARY OF INFORMATION REPORTED TO UKAB

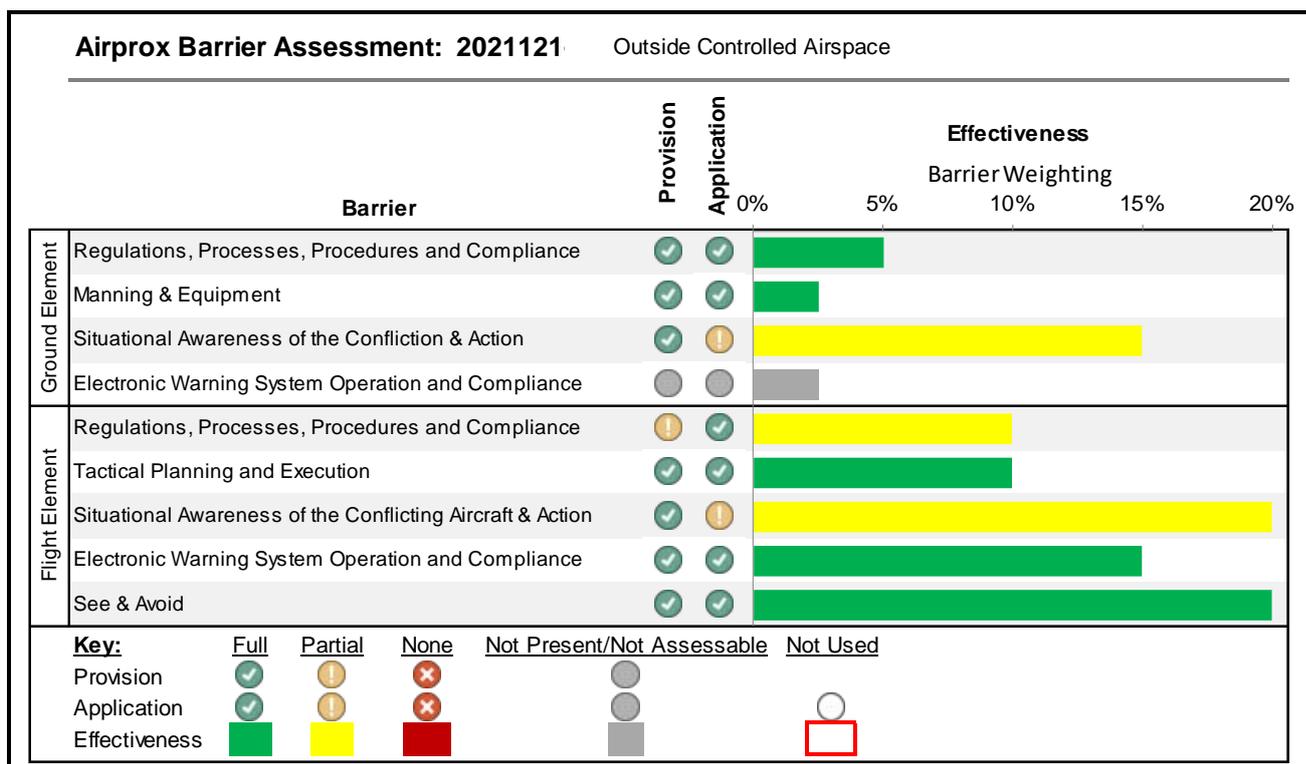
Regulations, Processes, Procedures and Compliance were assessed as **partially effective** because the military regulation in RA2307, concerning singleton aircraft giving way to formations, does not exist in civilian regulation and civilian regulation (UK) SERA.3210(a), requires a pilot to give way to an aircraft converging on the right.

Situational Awareness of the Conflicting Aircraft and Action were assessed as **partially effective** because both pilots continued to close proximity and the Prefect pilot did not alter their flight path.
