AIRPROX REPORT No 2021128

Date: 22 Jul 2021 Time: 1218Z Position: 5117N 00108W Location: 2NM N Basingstoke

PART A: SUMMARY OF INFORMATION REPORTED TO UKAB

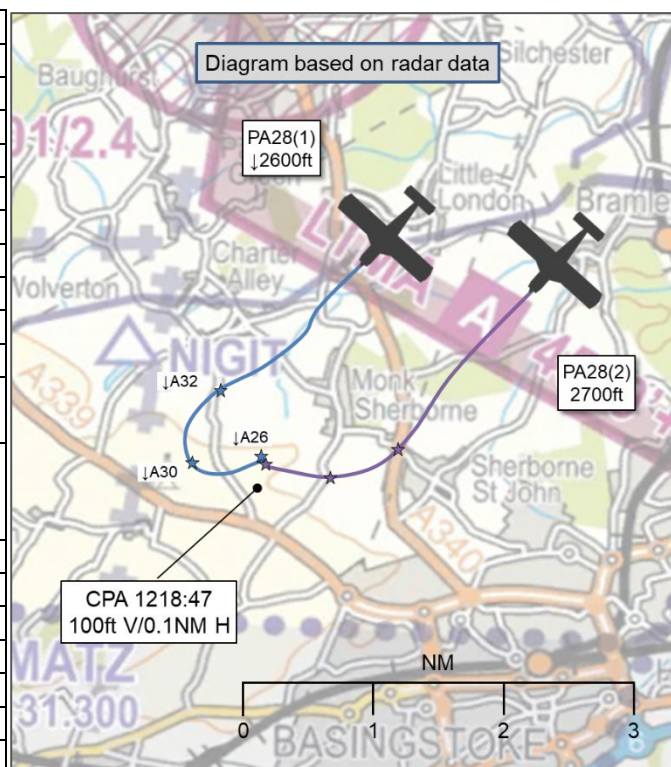
PA28(1) was on a Basic Service with Farnborough LARS West, operating in the NIGIT area. The LARS West frequency was busy, with medium to high workload including Traffic Services. PA28(1) was squawking 0441 (see Figure 1, screenshot taken from the Farnborough radar, PA28(1) circled in red).
