AIRPROX REPORT No 2021142

Date: 08 Aug 2021 Time: 1216Z Position: 5443N 00128W Location: 4NM SE of Durham

PART A: SUMMARY OF INFORMATION REPORTED TO UKAB

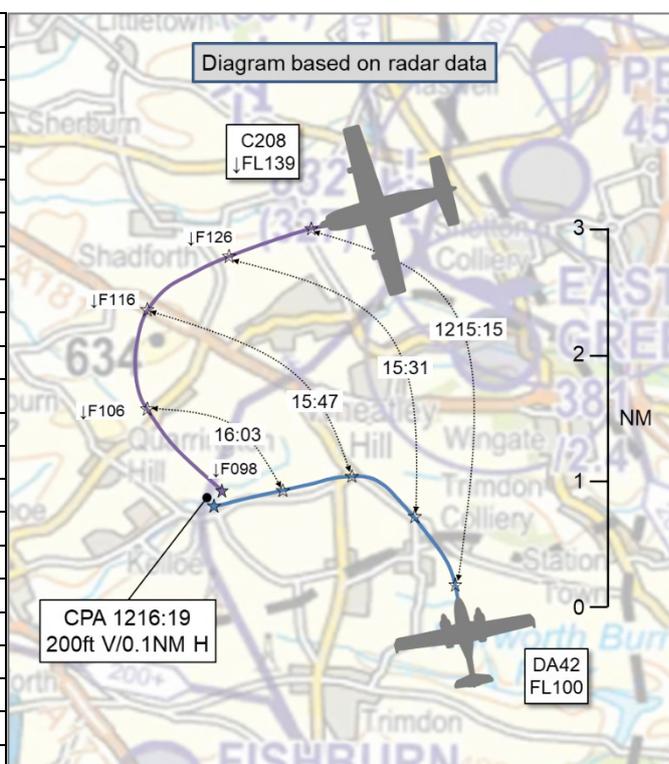
| Recorded | Aircraft 1 | Aircraft 2 |
|---|---|---|
| Recorded | 200ft V/0.1NM H | |

THE DA42 PILOT reports that, during a positioning flight from [departure airfield] to [destination airfield], passing in proximity of Shotton airfield, they had a close proximity with another aircraft (a DHC-6 Twin Otter, [they thought]); most likely a paradrop aircraft operating from Shotton which was descending after a drop. Just after leaving Teesside airspace, ATC informed them that there were parachuting activities at Shotton airfield from surface to FL160. They were south of Shotton at FL100 inbound NASGEB on a northerly track and turned left onto a heading of 350° to avoid the airspace. Teesside ATC transferred them to Newcastle Approach. After establishing contact with Newcastle ATC, the controller confirmed that they had a Traffic Service because they were outside controlled airspace, that Shotton parachuting was in progress and gave them a heading 340° to stay outside of Shotton dropping zone. A few moments later (at 1216) the controller asked them to turn onto a heading of 270° because of traffic in the vicinity that was descending and getting close to them. Shortly after, the controller informed them that the traffic was at their 2 o'clock above, descending and tracking in their direction; the traffic was spotted at the declared position at approximately 0.5NM and, after assessment, they judged that the traffic would pass below and behind them so they maintained their heading and altitude ready to conduct an evasive manoeuvre if the traffic were to alter its flightpath. The traffic was identified as a DHC-6 Twin Otter [they thought] and it passed at a distance of approximately 200m and approximately 150ft below their aircraft in their 4 o'clock. Their position was on the 243° radial at 5.1 NM from Shotton airfield (radial and distance obtained from their SkyDemon application). They reported clear of traffic to Newcastle ATC and also reported an Airprox; the controller instructed them to resume their own navigation inbound NATEB.
