AIRPROX REPORT No 2021146

Date: 11 Aug 2021 Time: 1305Z Position: 5155N 00209W Location: Gloucester airport

PART A: SUMMARY OF INFORMATION REPORTED TO UKAB

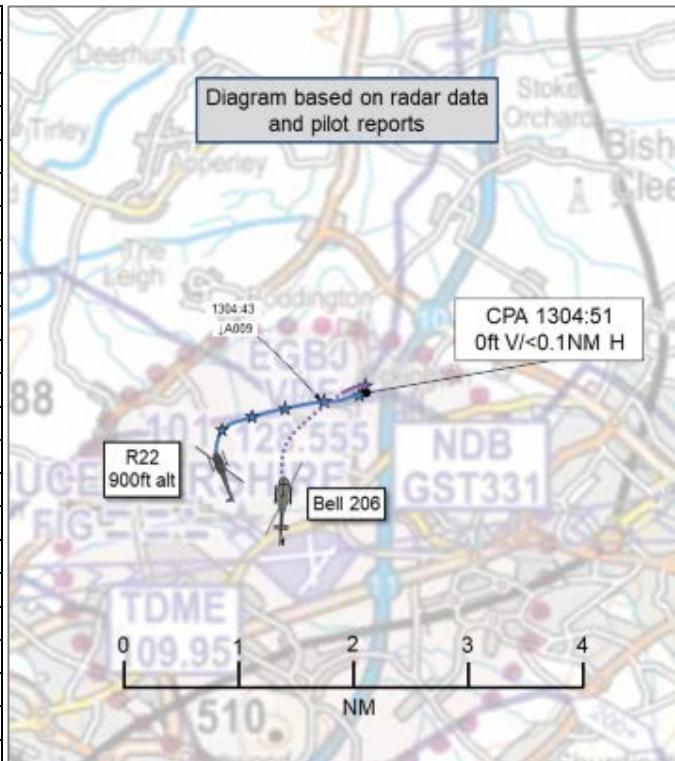
THE R22 PILOT reports that whilst conducting circuit training, mid-point downwind they heard their student suddenly take a sharp intake of breath before a [Bell 206] appeared, climbing right-to-left [crossing] directly in front of them, [it then banked to the] right before heading east-northeast.

The Airprox occurred at approximately 1305. [The R22 pilot] was conducting helicopter circuits based on RW27RH and had already completed a number (airborne time approximately 1240Z). The [Bell] pilot had been informed of the helicopter circuit being active during their previous sorties (most recently the flight immediately preceding that of the reported Airprox). There was a trainee on ADI with an ADI OJTI plugged in behind. The [Bell] pilot requested lift from the stand (sited just outside the terminal building) and was eventually given taxi to holding point A1 by the trainee [controller]. From A1 the Bell pilot was given a standard helicopter departure to the north and [instructed] to cross RW27. No Traffic Information was passed [to the Bell pilot] on the R22 in the helicopter circuit at this time or vice versa. From an eye witness account the [Bell] helicopter pilot crossed RW27 from A1 and routed pretty much directly to the north over the A + E building on the north-eastern airfield boundary. The Bell pilot was then observed to turn east as if they were joining the helicopter circuit which is where the confliction is believed to have occurred.

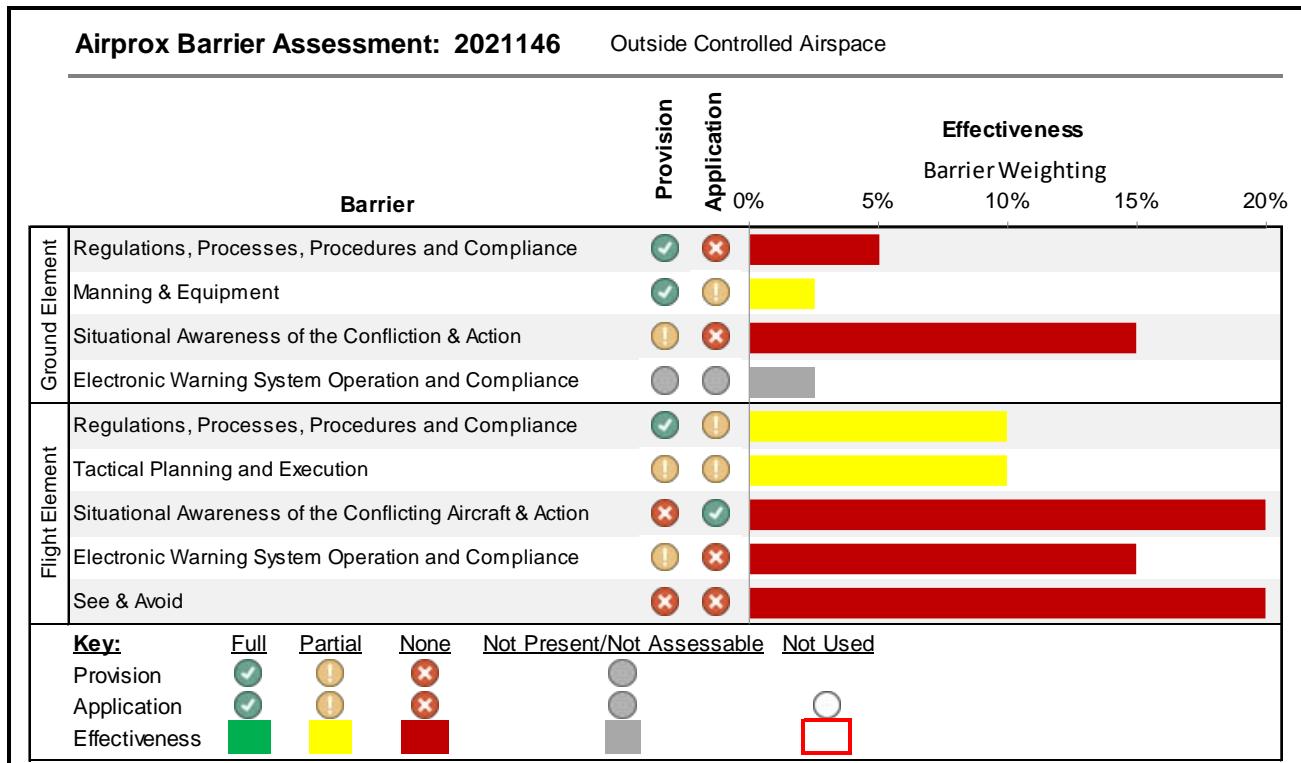
Electronic Warning System Operation and Compliance were assessed as **ineffective** because the TAS on the B206 did not alert when it would have been expected to.

See and Avoid were assessed as **ineffective** because neither pilot saw the other aircraft in time to take effective avoiding action.
