AIRPROX REPORT No 2021148

Date: 13 Aug 2021 Time: 1159Z Position: 5206N 00009E Location: Duxford

PART A: SUMMARY OF INFORMATION REPORTED TO UKAB

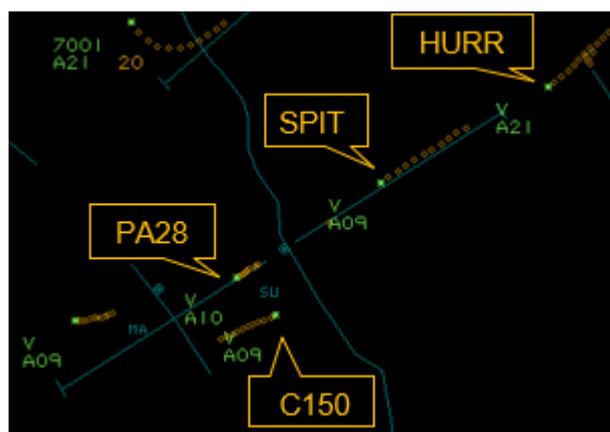
Figure 1 – 1147:27

At 1147:27 the FISO passed Traffic Information to the C150 pilot, “look out for a PA28 just airborne departing to the west or southwest and a Cub just getting airborne off the grass and also a Prefect on the go around into the left-hand circuit.” The Prefect referred to was not the Prefect involved in the Airprox. The C150 pilot reported visual with all 3 aircraft and was told to report final. The pilot confirmed it was for a touch-and-go and the FISO acknowledged and passed Traffic Information on the Spitfire running in. Note: The Cub was climbing away from RW24R at this point, and the unrelated Prefect (UR Prefect) was on the go around RW24L, neither aircraft are displayed in Figure 1 below.

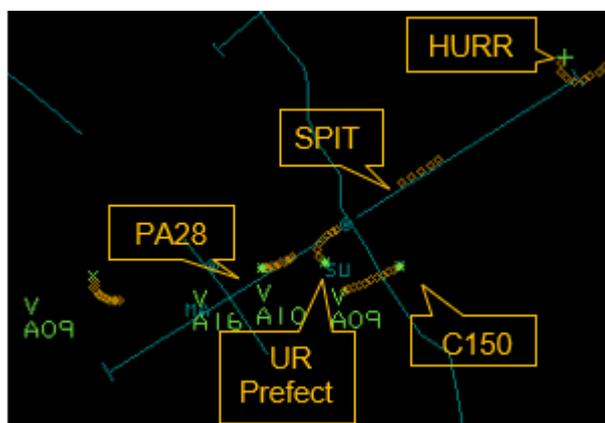
Figure 2 – 1148:13

At 1147:45 the Spitfire pilot reported at 2NM for the run-and-break and the FISO acknowledged. The FISO then turned their attention to aircraft on the ground and at 1148:13 the Spitfire pilot reported, “going up and above the Cub on the climb out.” The FISO acknowledged. (Figure 2)

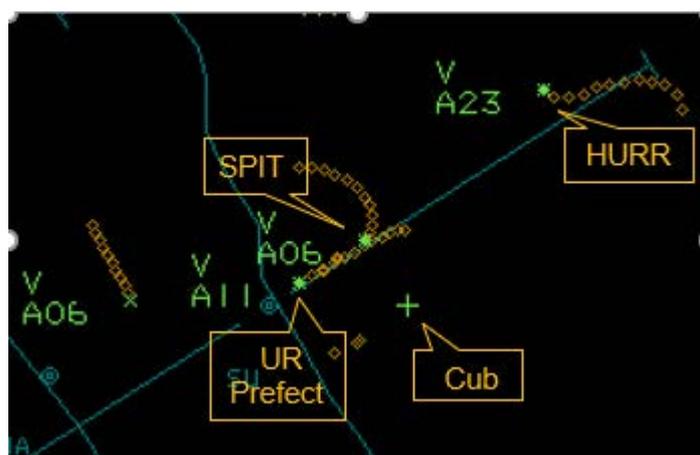
Figure 4 - 11:50:51

At 1150:51 the FISO turned their attention to an aircraft on the ground and issued the pilot with a line up clearance for RW24R (grass) (Figure 4).

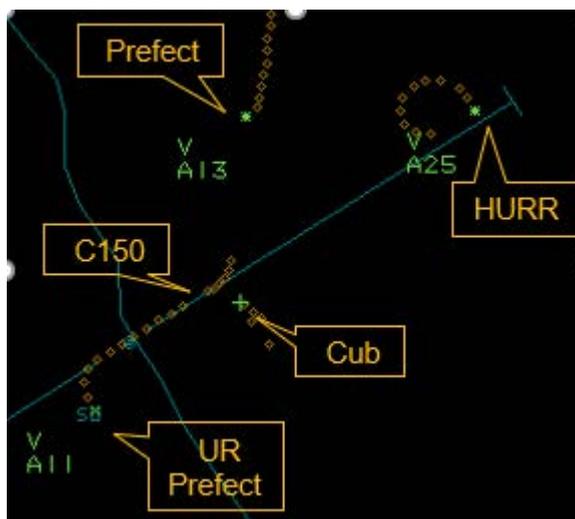
Figure 5 - 11:51.25

At 1151:15 the Spitfire Pilot was given a land at their discretion on RW24L (hard). At 1151:25 the Airprox Prefect pilot made initial contact with the FISO, using just their callsign and requested a Basic Service. The FISO queried the callsign and the pilot confirmed their callsign and requested to join. The FISO responded, "*join for 24 left-hand the QFE 1016, the circuit is active now with three in.*" The pilot read back, "*1016, three in.*" (Figure 5)

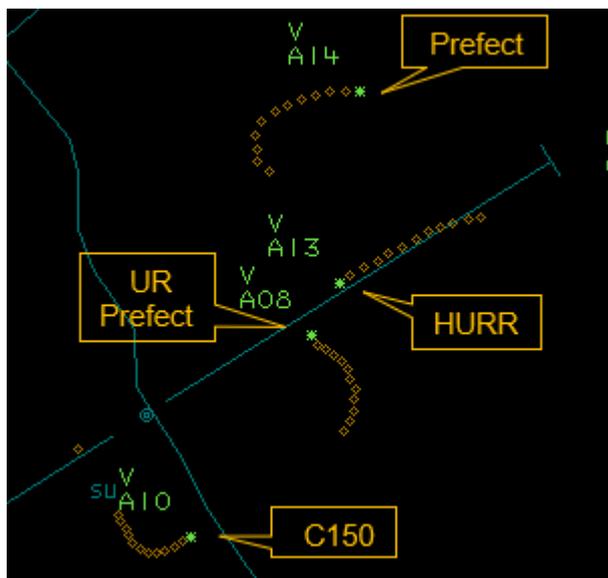
Figure 7 - 11:53.26

At 1153:26 the C150 pilot reported downwind and was told to report final. The pilot acknowledged (Figure 7).

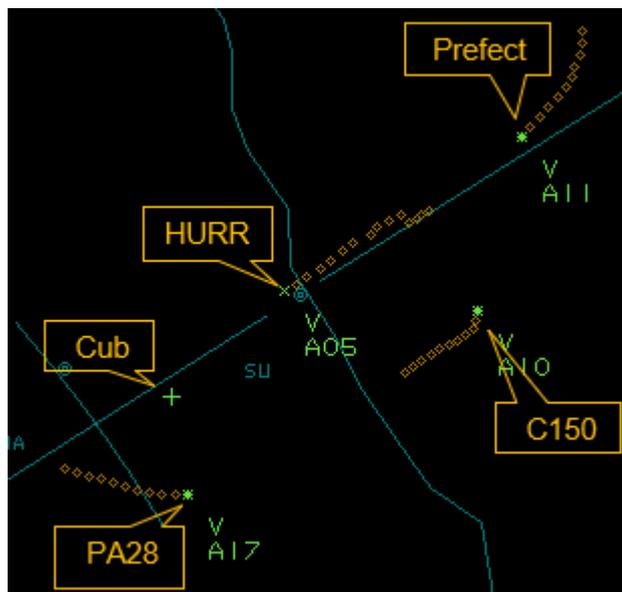
Figure 8 - 11:54.36

At 1154:36 the PA28 pilot called again requesting joining instructions and was given joining instruction for RW24L (hard) and advised that there were 3 or 4 in the circuit. The Hurricane pilot then reported breaking into the right-hand circuit and was told to report downwind. (Figure 8)

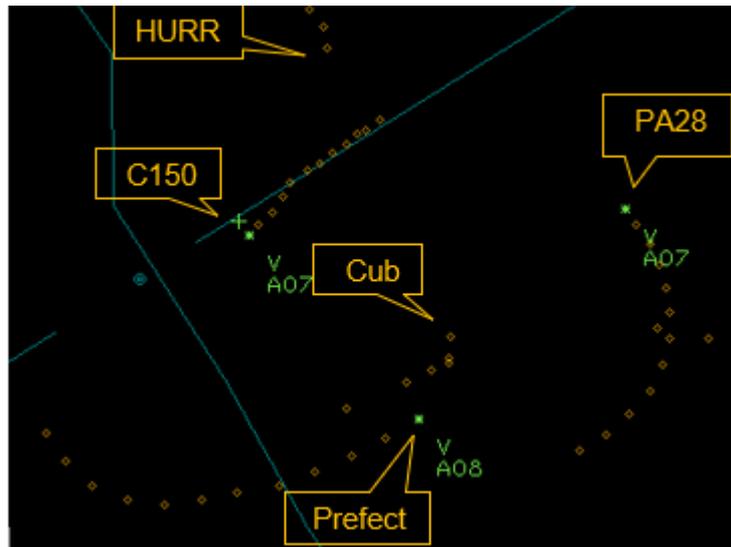
Figure 10 - 1156:58

At 1156:58 the FISO gave a land at your discretion on the grass to the Hurricane pilot and passed the instant wind of 260° 18kt. The Hurricane pilot acknowledged. (Figure 10)
