AIRPROX REPORT No 2021153

Date: 19 Aug 2021 Time: 1338Z Position: 5119N 00015E Location: 1NM S Brands Hatch

PART A: SUMMARY OF INFORMATION REPORTED TO UKAB

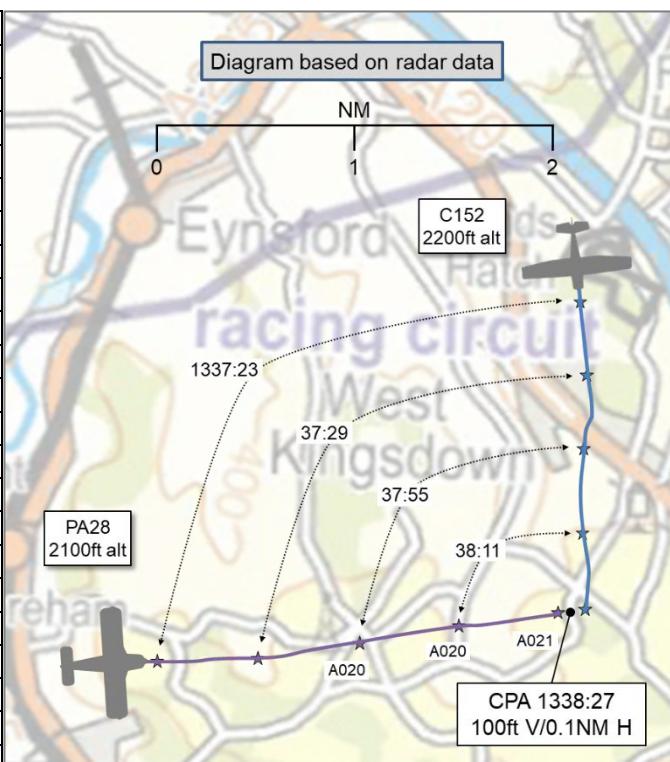
Recorded	Aircraft 1	Aircraft 2
Aircraft	C152	PA28
Operator	Civ FW	Civ FW
Airspace	London FIR	London FIR
Class	G	G
Rules	VFR	VFR
Service	Basic	AFIS
Provider	Farnborough East	Rochester Info
Altitude/FL	2200ft	2100ft
Transponder	A, C	A, C, S
Reported		
Colours	White	White
Lighting	Anti-Col	Strobes
Conditions	VMC	VMC
Visibility	>10km	>10km
Altitude/FL	2000ft	1900-2300ft
Altimeter	QNH (1014hPa)	QNH (1015hPa)
Heading	NR	095°
Speed	85kt	95kt
ACAS/TAS	Not fitted	Not fitted
Separation		
Reported	0ft V/30m H	50ft V/70-80m H
Recorded		100ft V/0.1NM H

THE C152 PILOT reports that they were on a VFR flight from [departure airfield] to [destination airfield] and were at 2000ft just south of 'London golf club', West Kingsdown. They were in receipt of a Basic Service from Farnborough east and keeping good lookout. Whilst looking out to their right, (the west) they saw an aircraft at the same height that appeared to be about to collide [with the] the side of their aircraft. Before they had had a chance to react, the pilot of the other aircraft spotted them and did a sharp left turn (to the north east). They report that they were pretty shocked and called on the radio '*aircraft to my right*', but had received no response from the [pilot of the other] aircraft. The C152 pilot opined that there had been a clear failure of both pilots to keep good lookout, but they felt that the pilot of the other aircraft had been in a much better position to see their aircraft and they were horrified that they [hadn't seen the C152] until it was almost too late.

The pilot assessed the risk of collision as 'High'.

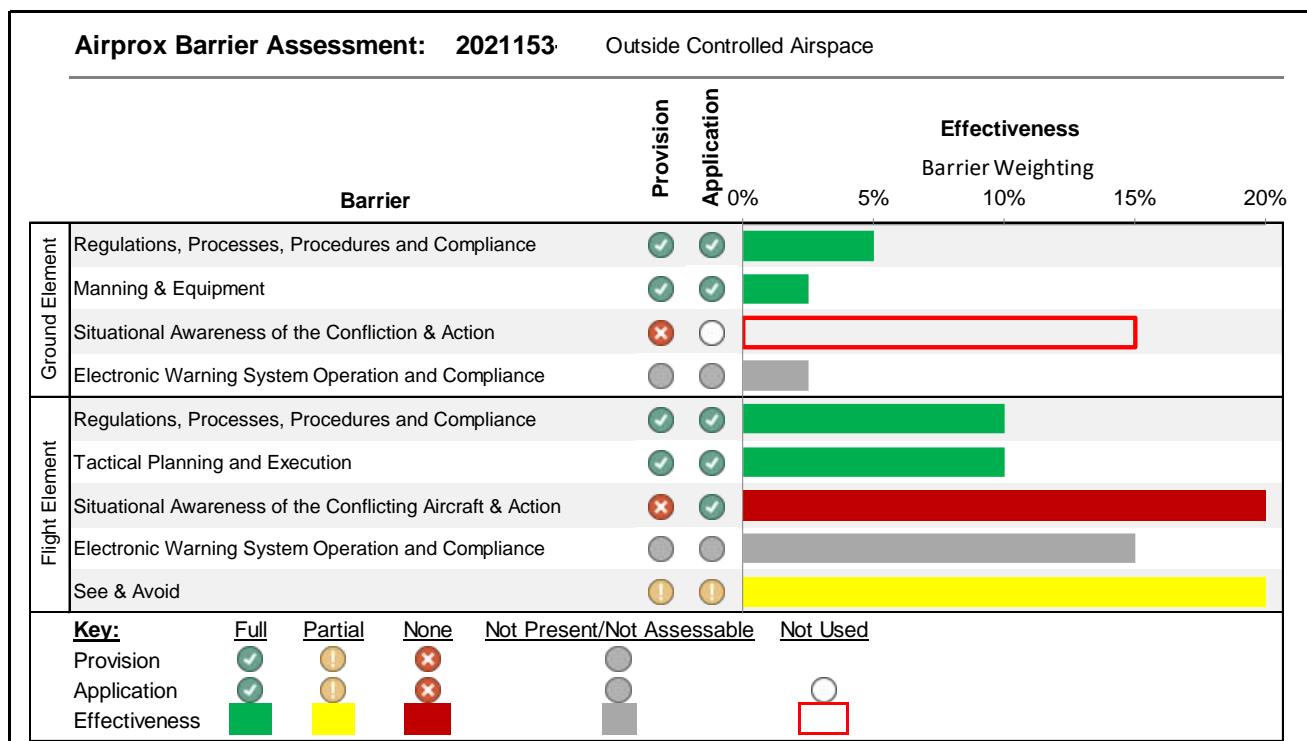
See and Avoid were assessed as **partially effective** because, the PA28 pilot only saw the C152 in time to take emergency avoiding action.
