AIRPROX REPORT No 2021160

Date: 25 Aug 2021 Time: ~1820Z Position: 5638N 00449W Location: Glencoe mountain resort

PART A: SUMMARY OF INFORMATION REPORTED TO UKAB

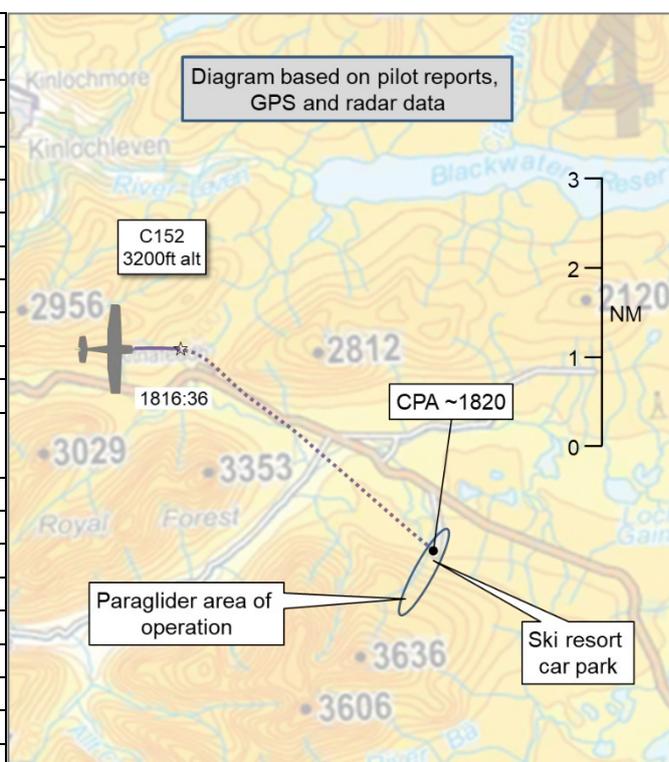
THE PARAGLIDER PILOT reports that they had been flying their paraglider round Glencoe for about 2½ hrs. They had set out across the valley heading north and had flown for maybe ½ or 1km to the east of the mountain resort car park at approximately 3000ft. Conditions were very good visibility, the sky was cloudless and it was a little after 1800, so shadows were getting long on the ground. To see anything to the west was difficult at times due to the low, strong sun and, in the event, they reported hearing the other aircraft before seeing it. They didn't see it until just before (maybe 3sec) it crossed in front of them. Both aircraft were at exactly the same altitude. They assumed that they would have been very visible to the other pilot as [the other pilot] had the sun behind them. They did not have a chance to note the registration but the [other] pilot did not appear to be looking in the direction [of the paraglider] and no avoiding action was taken [by the other pilot], and so they presumed they had not been seen. It was all over before they could take any action.

THE C152 PILOT reports that they were flying east along Glencoe. Roughly north of the Ski Centre they noticed the other aircraft at a similar height, heading roughly NW. They were in contact with Scottish Information who did not know of any traffic in the area, and there was no nearby traffic on frequency. They banked to the left after seeing the paramotor (they are not sure exactly what it was). At the closest point [they estimate that] there was approximately 800ft [lateral] separation. They informed Scottish Information that there was at least one [paraglider] operating in the area afterwards and continued east along Loch Rannoch. The paramotor [pilot] never joined the frequency.
