AIRPROX REPORT No 2021173

Date: 05 Sep 2021 Time: 1317Z Position: 5216N 00009E Location: 5NM N Cambridge airfield

PART A: SUMMARY OF INFORMATION REPORTED TO UKAB

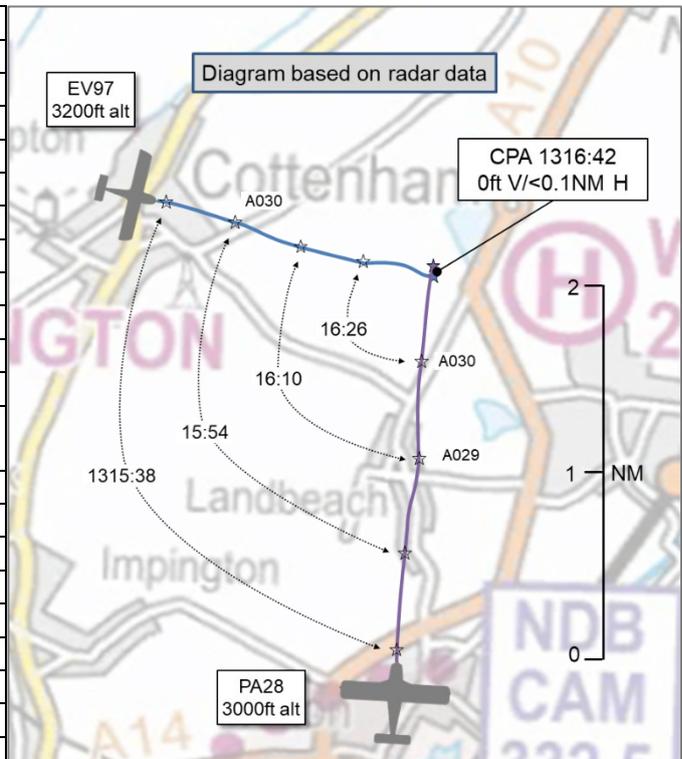
The EV97 was observed to also have been maintaining a relatively constant track and altitude up to the point at which CPA occurred, which happened between radar sweeps. The minimum recorded separation occurred approximately 1sec after actual CPA and was at 1316:42 (Figure 3). On the following radar sweep, the left turn made by the pilot of the EV97 was visible, and a descent registered on the Mode C readout, before the pilot then resumed their original heading.
