## AIRPROX REPORT No 2021178

Date: 11 Sep 2021 Time: 0900Z Position: 5329N 00225W Location: Barton ATZ

### PART A: SUMMARY OF INFORMATION REPORTED TO UKAB

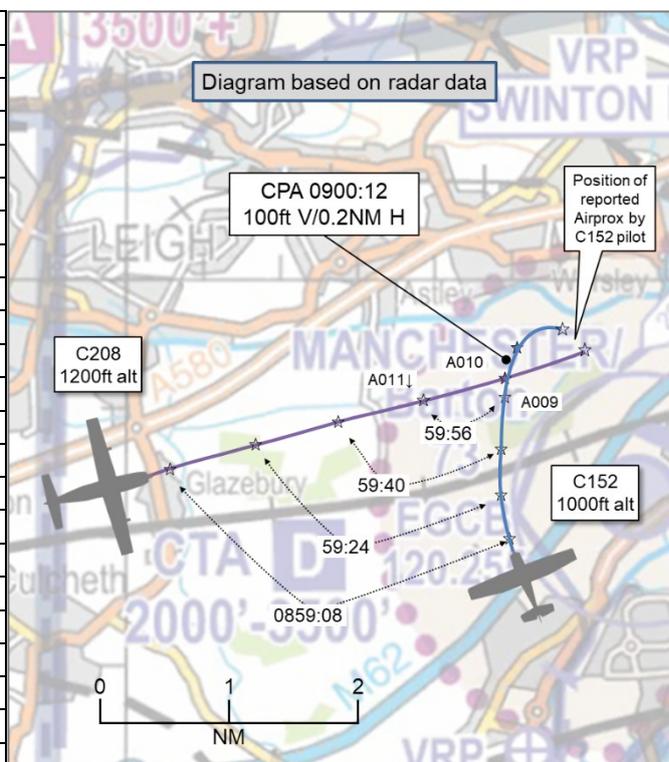
Recorded	Aircraft 1	Aircraft 2
Aircraft	C152	C208
Operator	Civ FW	Civ FW
Airspace	Barton ATZ	Barton ATZ
Class	G	G
Rules	VFR	VFR
Service	AFIS	None
Provider	Barton Info	None
Altitude/FL	900ft	1100ft
Transponder	A, C, S	A, C, S
Reported		
Colours	White	White, blue, red
Lighting	Full	Beacon, landing
Conditions	VMC	VMC
Visibility	>10km	>10km
Altitude/FL	1000ft	1050ft
Altimeter	QNH (1015hPa)	QNH (NK hPa)
Heading	NK	075°
Speed	90kt	135kt
ACAS/TAS	Not fitted	TCAS I
Alert	N/A	None
Separation at CPA		
Reported	0ft V/50m H	0ft V/1.5NM H
Recorded	100ft V/0.2NM H
