AIRPROX REPORT No 2021184

Date: 16 Sep 2021 Time: 1729Z Position: 5211N 00107W Location: DTY VOR

PART A: SUMMARY OF INFORMATION REPORTED TO UKAB

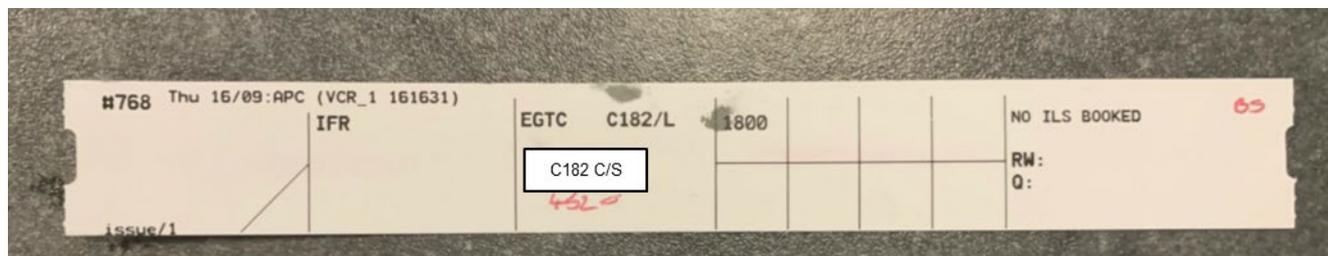
C182 FPS

[C182 C/S] was booked in IFR from Cranfield (See Attachment: C182 FPS) and first made contact with Oxford radar at 17:21 UTC whereby the following exchange occurred:
