AIRPROX REPORT No 2021186

Date: 16 Sep 2021 Time: ~1329Z Position: 5213N 00002W Location: 0.5NM N Bourn airfield

PART A: SUMMARY OF INFORMATION REPORTED TO UKAB

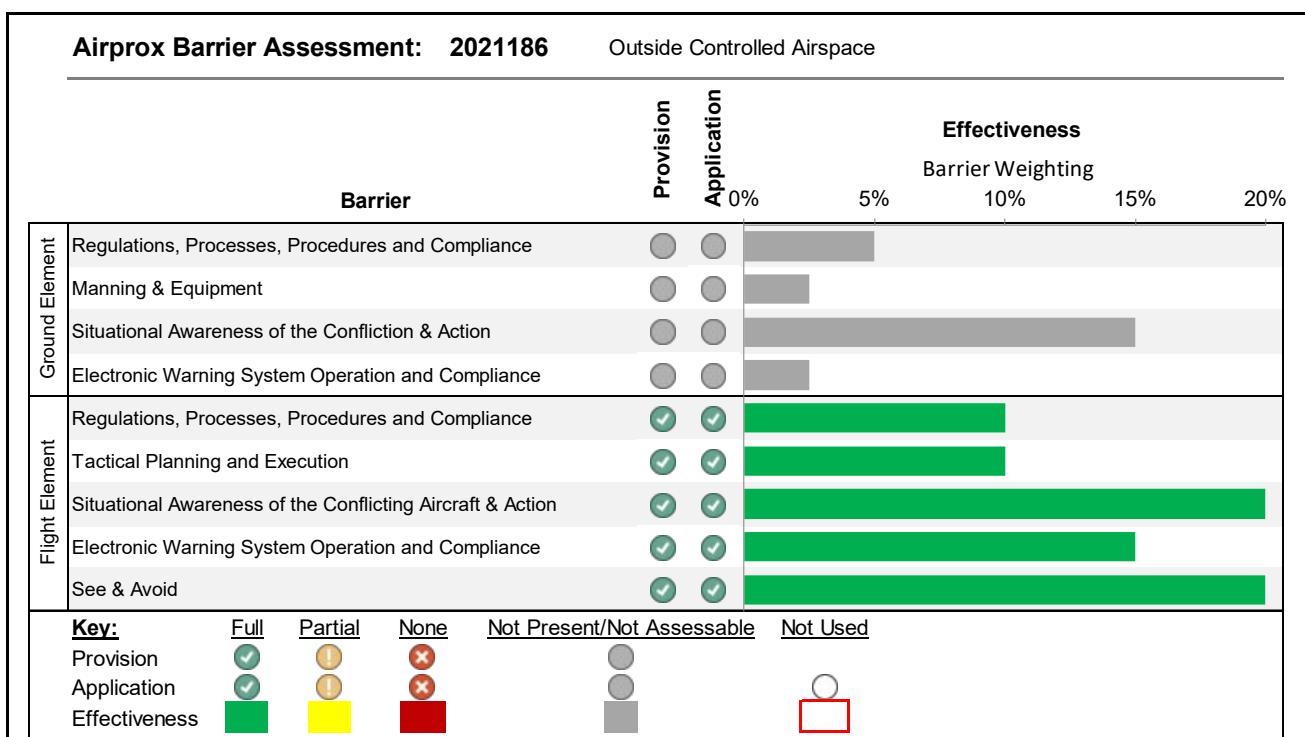
Safety Barrier Assessment⁵

In assessing the effectiveness of the safety barriers associated with this incident, the Board concluded that all relevant barriers to mid-air collision had functioned as intended.
