AIRPROX REPORT No 2021188

Date: 16 Sep 2021 Time: 1326Z Position: 5110N 00105W Location: 1.5NM W Lasham airfield

PART A: SUMMARY OF INFORMATION REPORTED TO UKAB

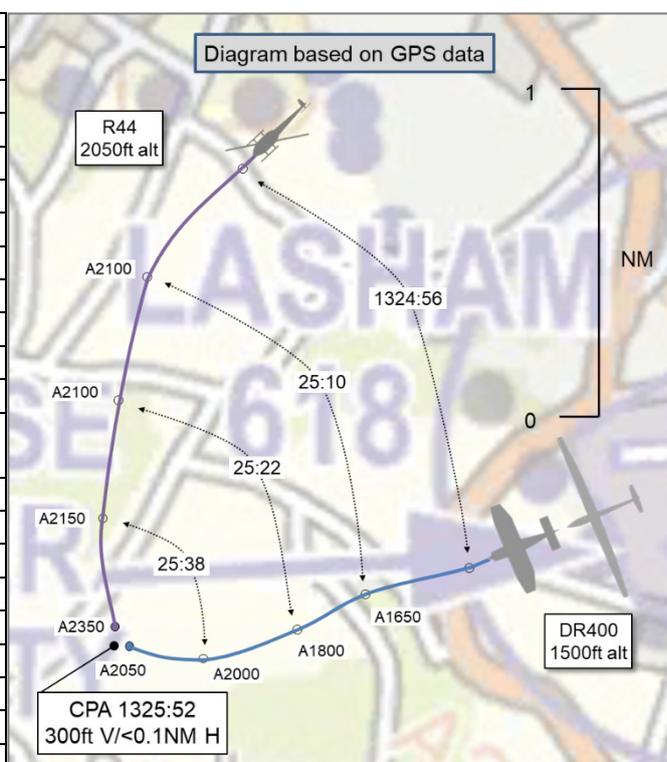
Recorded	Aircraft 1	Aircraft 2
Aircraft	DR400	R44
Operator	Civ FW	Civ Helo
Airspace	London FIR	London FIR
Class	G	G
Rules	VFR	VFR
Service	Listening Out	Basic
Provider	Lasham	Odiham Approach
Altitude/FL	2050ft	2350ft
Transponder	A, C	A, C, S
Reported		
Colours	Black, yellow	Yellow
Lighting	Strobes, Beacon, Taxi	Strobes
Conditions	Choose an item.	VMC
Visibility	5-10km	5-10km
Altitude/FL	1200ft aal	2000ft
Altimeter	QFE (NK hPa)	QNH (NK hPa)
Heading	270°	180°
Speed	70kt	90kt
ACAS/TAS	FLARM	PilotAware
Alert	None	Information
Separation at CPA		
Reported	300ft V/<100m H	NK V/NK H
Recorded	300ft V/<0.1NM H
