AIRPROX REPORT No 2021192

Date: 21 Sep 2021 Time: 1233Z Position: 5159N 00035W Location: 5.5NM S Cranfield airport

PART A: SUMMARY OF INFORMATION REPORTED TO UKAB

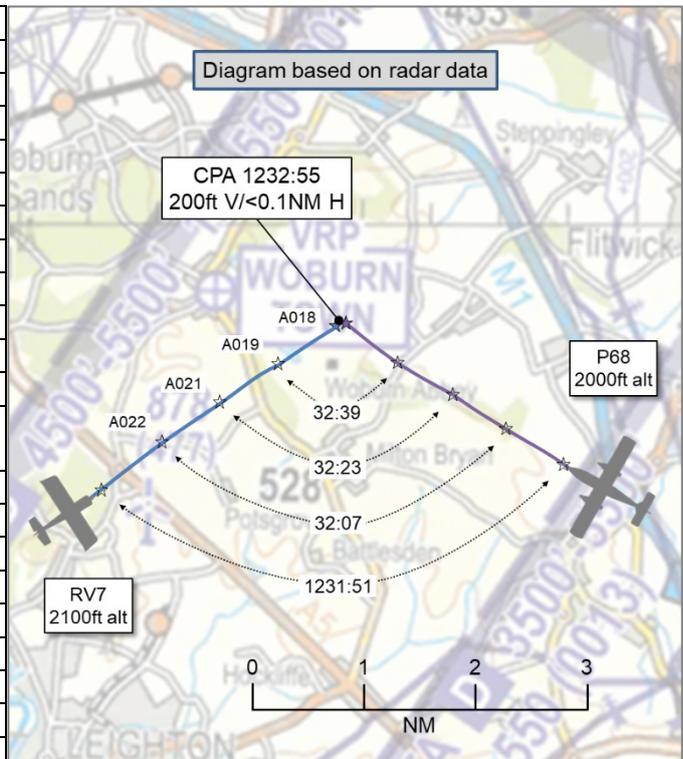
Recorded	Aircraft 1	Aircraft 2
Aircraft	RV7	P68
Operator	Civ FW	Civ Comm
Airspace	London FIR	London FIR
Class	G	G
Rules	VFR	VFR
Service	Listening Out	Basic
Provider	Old Warden Radio	Luton Radar
Altitude/FL	1800ft	2000ft
Transponder	A, C, S	A, C, S
Reported		
Colours	White, red, silver	White, blue
Lighting	Nav, Strobe	Nav, Anti-col, Taxy Beacon, Landing
Conditions	VMC	VMC
Visibility	>10km	>10km
Altitude/FL	1100ft	2000ft
Altimeter	QNH (1031hPa)	QNH (1031hPa)
Heading	045°	310°
Speed	135kt	140kt
ACAS/TAS	PilotAware	Not fitted
Alert	None	N/A
Separation at CPA		
Reported	400ft V/0 H	500ft V/300m H
Recorded	200ft V/<0.1NM H
