AIRPROX REPORT No 2021201

Date: 29 Sep 2021 Time: 1208Z Position: 5028N 00020W Location: 3NM W Conington

PART A: SUMMARY OF INFORMATION REPORTED TO UKAB

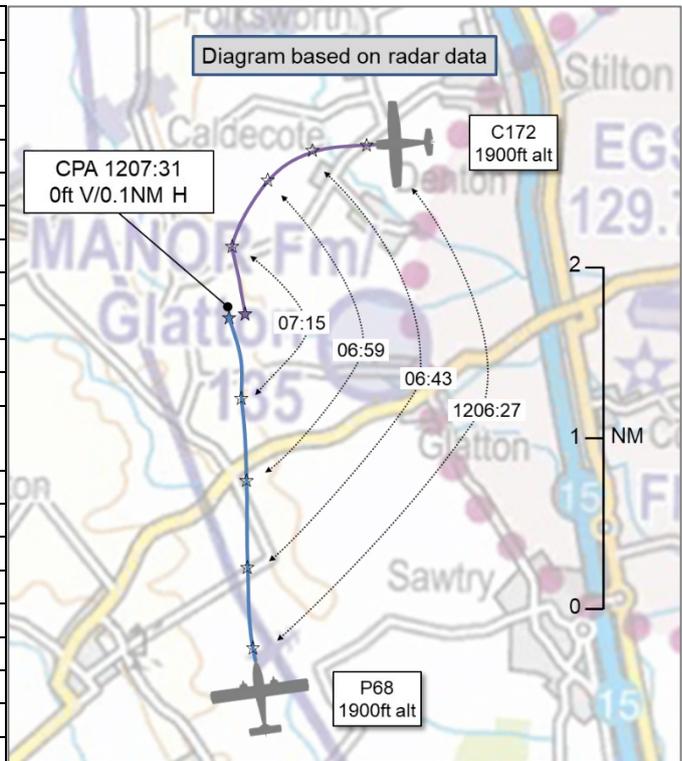
THE P68 PILOT reports that they were doing line 12 of the day when they suddenly had to break off due to traffic turning directly towards them from about 0.5NM away. At this point, they were in contact with Wittering on VHF-COM1 as they have radar and can provide Traffic Information. On VHF-COM2 they were monitoring Peterborough Conington airfield as it is close to the survey area. About 45sec before the occurrence, the Radar controller notified them of the traffic and they reported back that they were visual with the mentioned traffic. The traffic was crossing them from right-to-left at the same altitude which, on their present course, was no problem at all. When the traffic was in their 1 o'clock, it took a steep left turn, putting them on course directly towards the P68. Their immediate response was full power, and then a steep left turn to avoid. At this point, they estimated that the traffic was about 0.2NM from them. They then asked Wittering on VHF-COM1 if they had contact with the traffic to which they replied they didn't. They then asked Conington on VHF-COM2 and [recall them replying that] they didn't have contact with them either. They were told that they were squawking 7000 and probably not talking to anyone. After the event, they decided to leave the area and go to a less congested area.

The P68 pilot was conducting line 12 of the day and reported that they had to break-off due to the C172 turning towards them around 0.5NM away. They reported that they received Traffic Information from Wittering ATC and were also monitoring Peterborough Conington due to its proximity to the survey site. They reported that the C172 was crossing left-to-right at the same altitude which did not pose a hazard, however, it was reported that the C172 took a steep left turn towards the P68 which was then required to take avoiding action. Separation was reported as 0.2NM horizontally and 0ft vertically.
