## AIRPROX REPORT No 2021212

Date: 12 Oct 2021 Time: 1405Z Position: 5105N 00247W Location: 8NM NW Yeovilton

### PART A: SUMMARY OF INFORMATION REPORTED TO UKAB

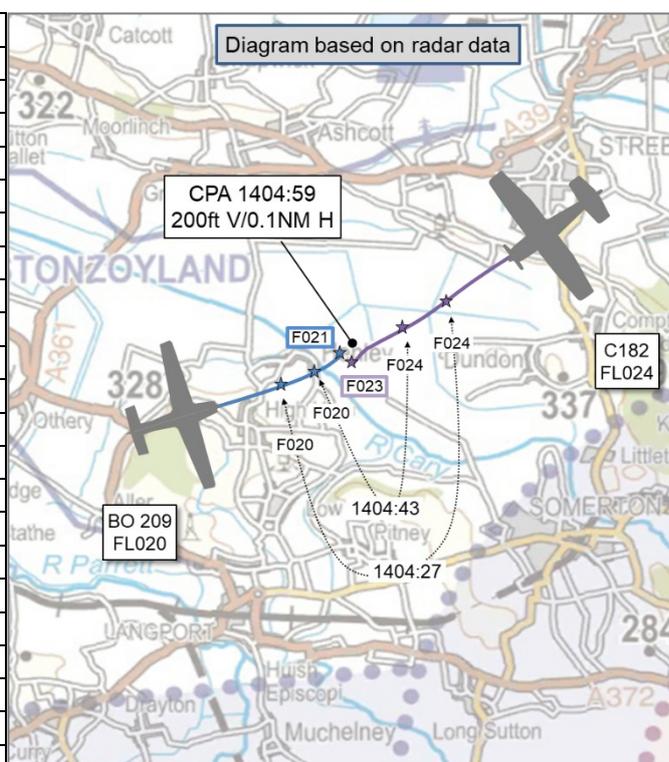
**THE C182 PILOT** reports that they spotted the other aircraft during lookout half a mile away, dead ahead at the same altitude or slightly below. The other aircraft did not appear on their CWS conspicuity screen, which they knew was working as just minutes earlier it had alerted to another aircraft's proximity (which they subsequently saw). Both aircraft were flying with landing lights on, and the light on the other aircraft was the first thing that they noticed. Had the other aircraft not had their light on, they thought they would probably not have noticed it when they did. They both turned to their respective left and created separation. The pilot opined that no one was at fault, but if the other aircraft had ADS-B-out, this Airprox would have been avoided. Yeovil Radar was very busy, so they did not report it at the time, they struggled to get their QSY call in.

**THE BO 209 PILOT** reports that they were receiving intermittent CWS information on the other aircraft. The landing light of the other aircraft was then seen, they made a turn to the left and the opposing aircraft passed on their right-hand side at a horizontal range of 500-600m.
