AIRPROX REPORT No 2021223

Date: 02 Nov 2021 Time: 1513Z Position: 5307N 00236W Location: 4.5NM SW Winsford

PART A: SUMMARY OF INFORMATION REPORTED TO UKAB

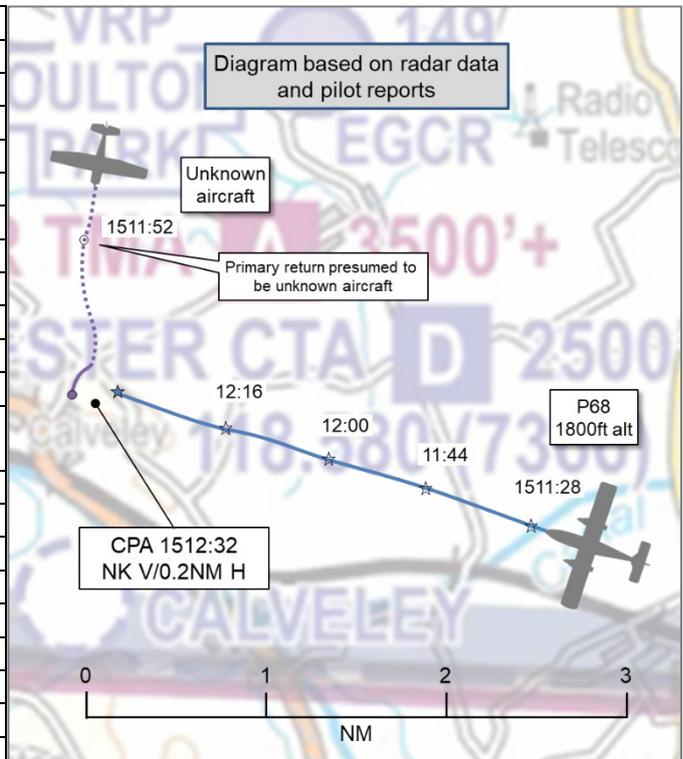
THE P68 PILOT reports that an aircraft was spotted in their 12 o'clock position at the same altitude moving right to left. The aircraft was a small single-engine aircraft. They were preparing for a visual approach to [destination airfield] at the time of the incident. They were in contact with Hawarden Radar on a Basic Service. The other aircraft did not show up on their ACAS. They felt that the other aircraft may have just transited through the Manchester low-level route. They report that there had been little or no time for evasive manoeuvres.
