### **AIRPROX REPORT No 2022011**

Date: 11 Feb 2022 Time: 1553Z Position: 5154N 00001E Location: 1NM N Puckeridge VRP

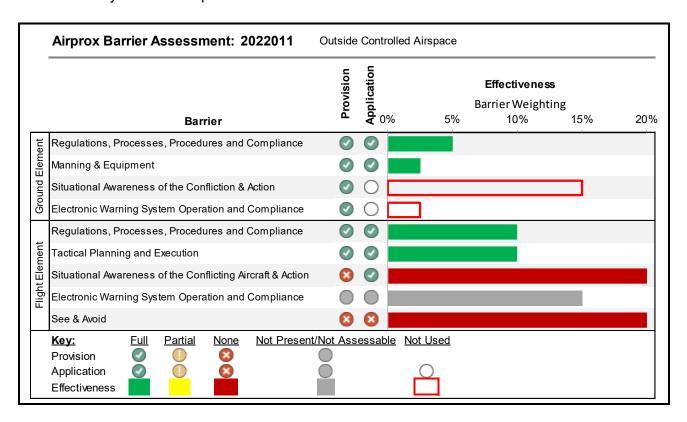
**See and Avoid** were assessed as **ineffective** because neither pilot saw the other aircraft in time to materially affect the separation.
