AIRPROX REPORT No 2022080

Date: 14 May 2022 Time: 1035Z Position: 5224N 00131E Location: 4.5NM SW Beccles Airfield

PART A: SUMMARY OF INFORMATION REPORTED TO UKAB

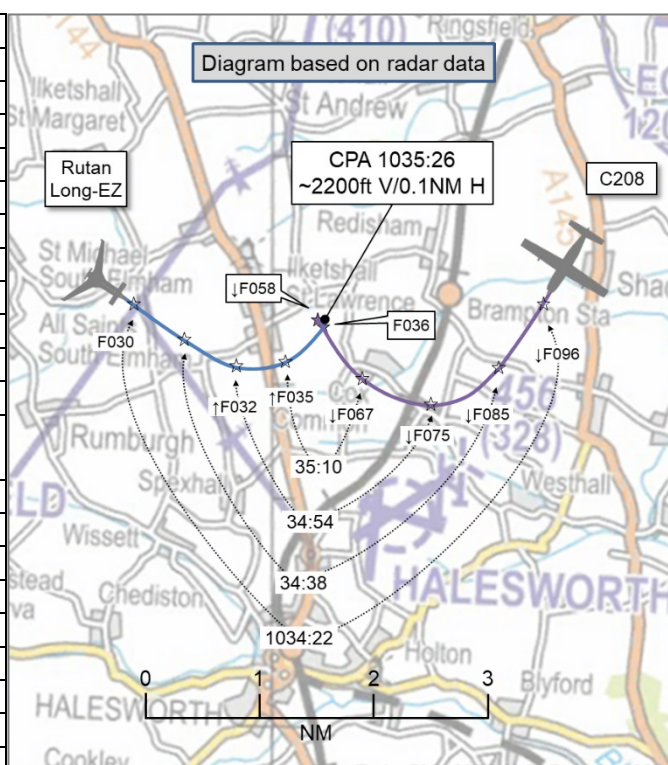
Recorded	Aircraft 1	Aircraft 2
Aircraft	Rutan Long-EZ	C208
Operator	Civ FW	Civ Comm
Airspace	London FIR	London FIR
Class	G	G
Rules	VFR	VFR
Service	Basic	Traffic
Provider	Norwich Radar	Norwich Radar
Altitude/FL	FL036	FL058
Transponder	A, C, S	A, C, S
Reported		
Colours	White, Blue	White
Lighting	Nav, Strobe	Nav, Beacon, Landing, Taxi
Conditions	VMC	VMC
Visibility	>10km	>10km
Altitude/FL	3200ft	4300ft
Altimeter	QNH (NR hPa)	QFE (NR hPa)
Heading	360°	323°
Speed	127kt	139kt
ACAS/TAS	PilotAware	Not fitted
Alert	TA	N/A
Separation at CPA		
Reported	100ft V/150m H	Not seen
Recorded	~2200ft V/0.1NM H
