AIRPROX REPORT No 2022138

Date: 14 Jul 2022 Time: 1205Z Position: 5157N 00140W Location: 1NM E Stow-on-the-Wold

PART A: SUMMARY OF INFORMATION REPORTED TO UKAB

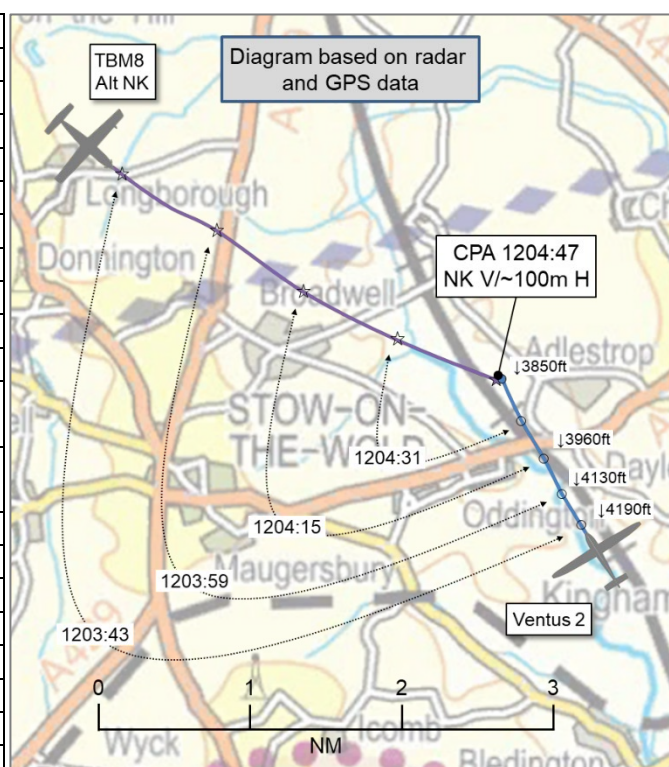
The Oxford unit investigation report does not contain radar screenshots; it states that the replay of the Oxford radar recording resulted in confirmation that a primary-only radar contact was observed merging and garbling with the radar contact of the TBM8 at the point where the pilot had called the controller for re-join instructions.

It is recommended that pilots obtain the best ATC service available to assist in prevention of MAC. In this case the glider wasn't equipped with a transponder and the EC available wasn't compatible, leaving the last barrier of lookout for MAC avoidance. This was a good spot by both the TBM and glider pilots, just allowing time for avoiding action to be taken.
