AIRPROX REPORT No 2022162

Date: 06 Aug 2022 Time: 1559Z Position: 5042N 00102W Location: 3NM ENE Bembridge

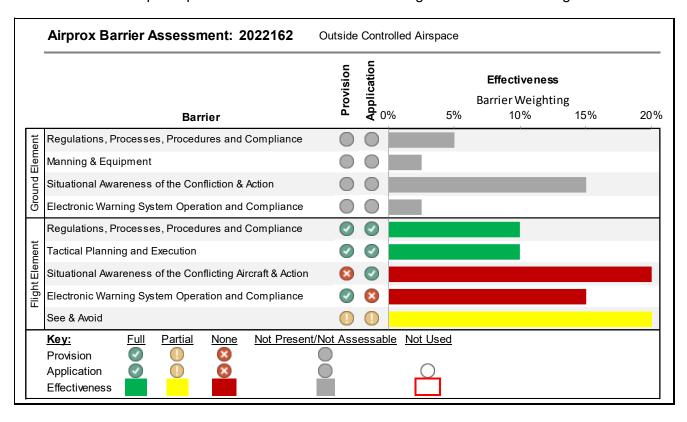
Electronic Warning System Operation and Compliance were assessed as **ineffective** because the EC equipment fitted to each aircraft would have been expected to have provided an alert to the presence of the other, but no alert was reported.

See and Avoid were assessed as **partially effective** because the pilot of the Spitfire had been focussed on the timing of their holding manoeuvre in preparation for commencing an air-display and had effectively not sighted the EV97. The nose cowling of the Spitfire had obscured the EV97 from the view of the Spitfire pilot and this had led to late avoiding action when it was sighted.
