## AIRPROX REPORT No 2023037

Date: 30 Mar 2023 Time: 0901Z Position: 5251N 00047E Location: Sculthorpe

### PART A: SUMMARY OF INFORMATION REPORTED TO UKAB

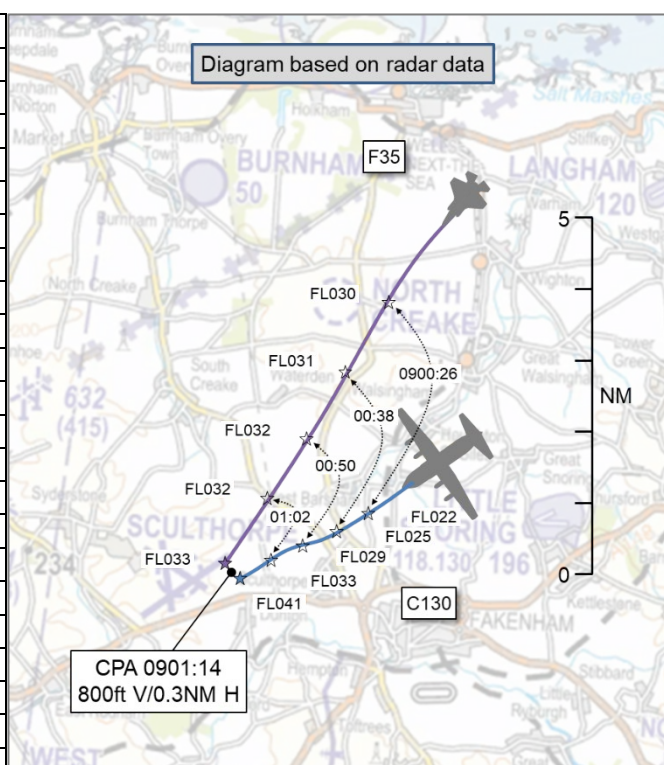
Recorded	Aircraft 1	Aircraft 2
Aircraft	C130	F35
Operator	Foreign Mil	HQ Air (Ops)
Airspace	London FIR	London FIR
Class	G	G
Rules	IFR <sup>1</sup>	VFR
Service	Traffic	Traffic
Provider	Swanwick (Mil)	Marham
Altitude/FL	FL041	FL033
Transponder	A, C, S+	A, C, S+
<b>Reported</b>		
Colours	Grey	Grey
Lighting	NR	HISL, nav
Conditions	VMC	VMC
Visibility	>10km	>10km
Altitude/FL	2000ft climbing	2500ft
Altimeter	QNH (NK hPa)	NK (NK hPa)
Heading	270°	180°
Speed	NK	320kt
ACAS/TAS	TCAS II	Not fitted
Alert	RA	N/A
<b>Separation at CPA</b>		
Reported	300ft V/0m H	0ft V/1NM H
Recorded	800ft V/0.3NM H
