AIRPROX REPORT No 2023044

Date: 02 Apr 2023 Time: 1334Z Position: 5316N 00046W Location: 6NM E of Retford/Gamston

PART A: SUMMARY OF INFORMATION REPORTED TO UKAB

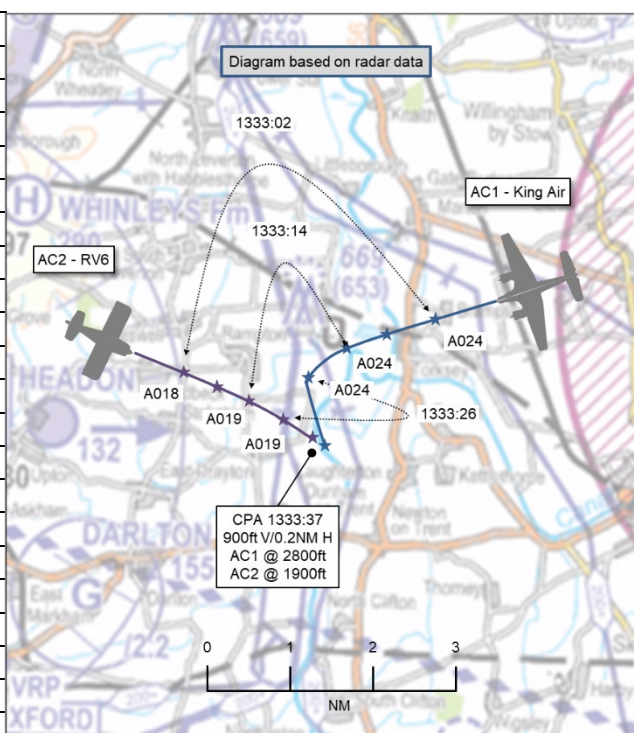
Recorded	Aircraft 1	Aircraft 2
Aircraft	King Air	RV6
Operator	Civ Comm	Civ FW
Airspace	London FIR	London FIR
Class	G	G
Rules	VFR	VFR
Service	AGCS	None
Provider	Gamston Radio	N/A
Altitude/FL	2800ft	1900ft
Transponder	A, C, S+	A, C, S
Reported		
Colours	White/Blue Stripes	Red/White
Lighting	Beacon/Nav/Position	Strobes
Conditions	VMC	VMC
Visibility	>10km	>10km
Altitude/FL	2500ft	1600ft
Altimeter	QNH (1030hPa)	QNH (NR)
Heading	270°	SE
Speed	180kt	130kt
ACAS/TAS	TCAS II	Not fitted
Alert	RA	N/A
Separation at CPA		
Reported	300ft V/0.0NM H	NR V/NR H
Recorded	900ft V/0.2NM H
