AIRPROX REPORT No 2023055

Date: 17 Apr 2023 Time: 1526Z Position: 5305N 00013W Location: Coningsby

PART A: SUMMARY OF INFORMATION REPORTED TO UKAB

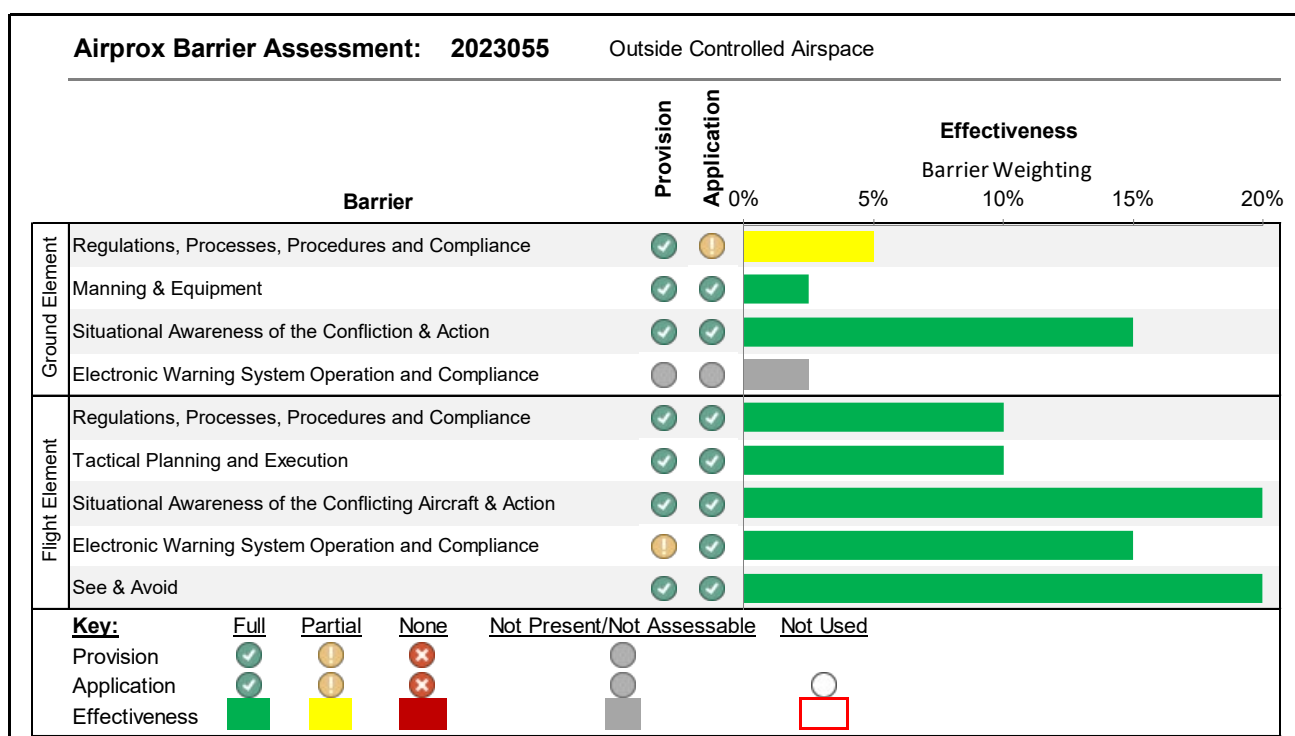
Ground Elements:

Regulations, Processes, Procedures and Compliance were assessed as **partially effective** because the MAP phraseology used by ATC was not in accordance with CAP413 and was ambiguous.
