## AIRPROX REPORT No 2023079

Date: 18 May 2023 Time: 1342Z Position: 5336N 00042W Location: 2NM NW Scunthorpe

### PART A: SUMMARY OF INFORMATION REPORTED TO UKAB

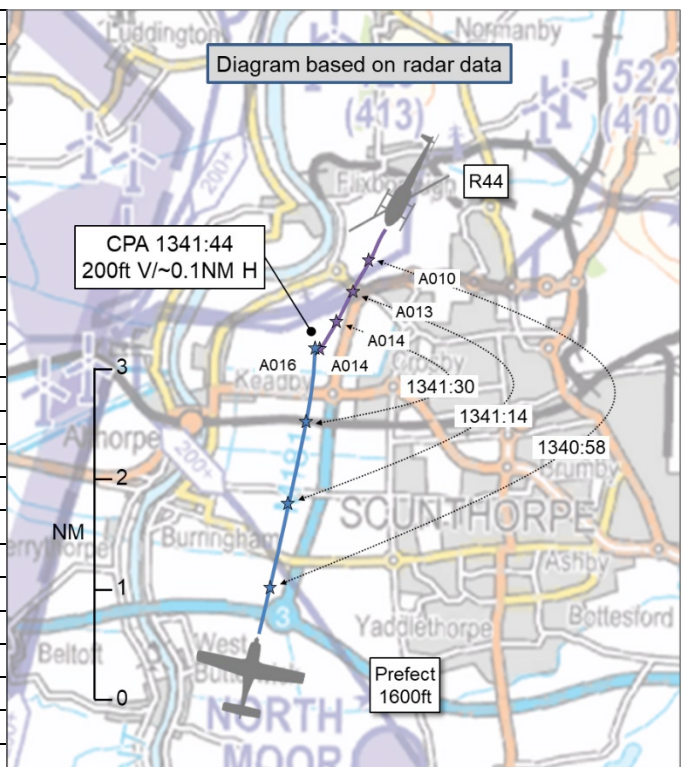
The moment of CPA was determined to have occurred between the radar sweeps at 1341:42 and 1341:46 (see Figures 1 and 2). It was observed that pilot of the Prefect had turned sharply to the right approximately at the moment of CPA, but it could not be determined whether this turn had been initiated in the moments before or after CPA had occurred.

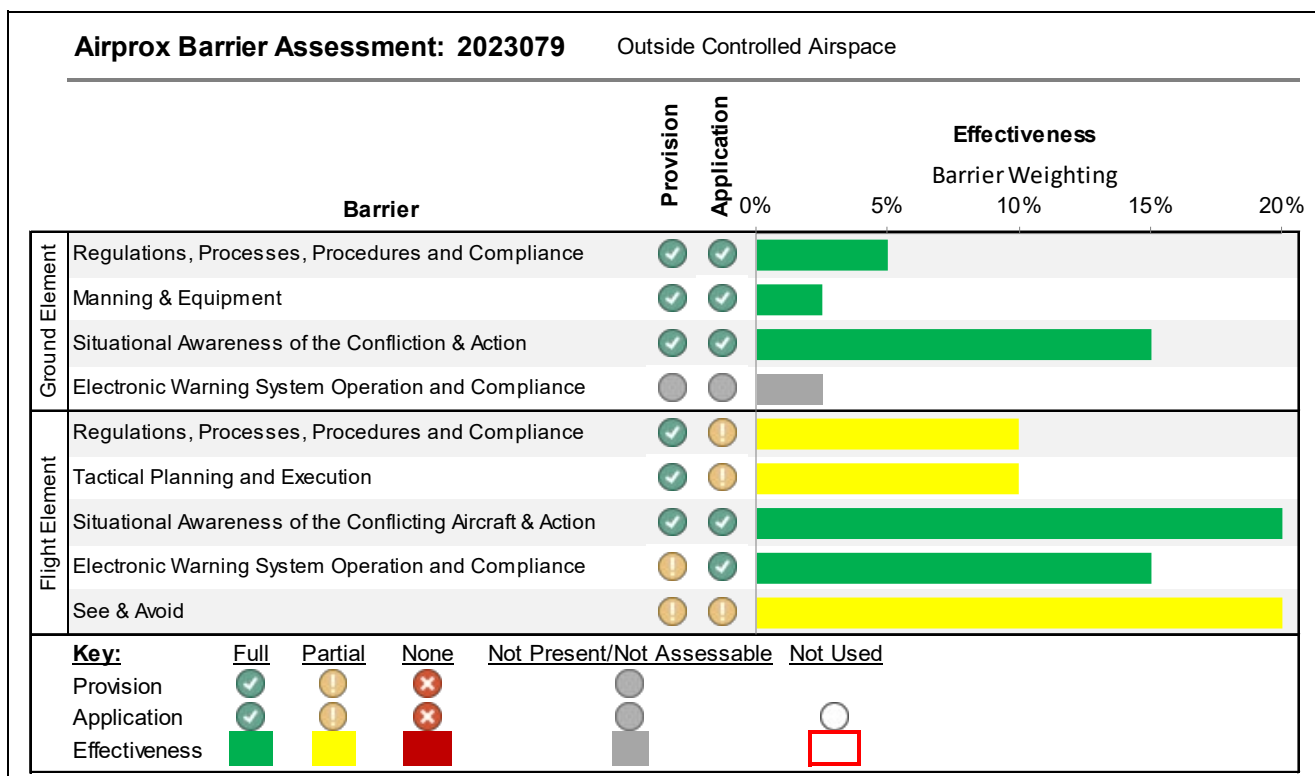
**Tactical Planning and Execution** was assessed as **partially effective** because the pilot of the Prefect had not requested an appropriate ATS.

**See and Avoid** were assessed as **partially effective** because both pilots had visually acquired the other aircraft late.
