AIRPROX REPORT No 2023097

Date: 23 May 2023 Time: 1614Z Position: 5223N 00007E Location: 5NM W Ely

PART A: SUMMARY OF INFORMATION REPORTED TO UKAB

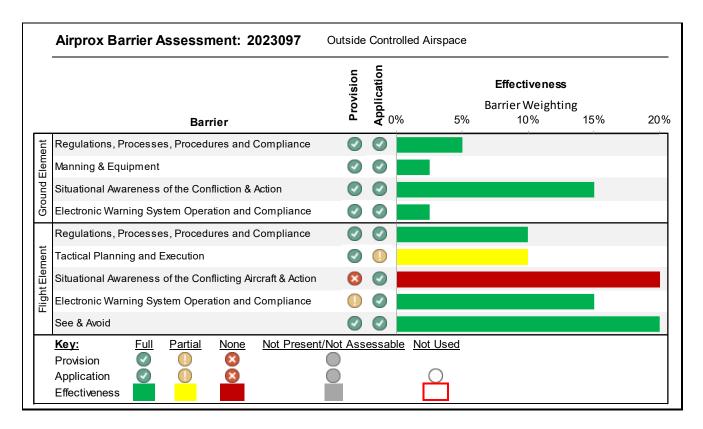
Situational Awareness of the Conflicting Aircraft and Action were assessed as **ineffective** because the pilot of the G115 had not had situational awareness of the presence of the KC135 until it had been visually acquired.
