AIRPROX REPORT No 2023103

Date: 03 Jun 2023 Time: ~0945Z Position: 5213N 00137W Location: Wellesbourne Mountford ATZ

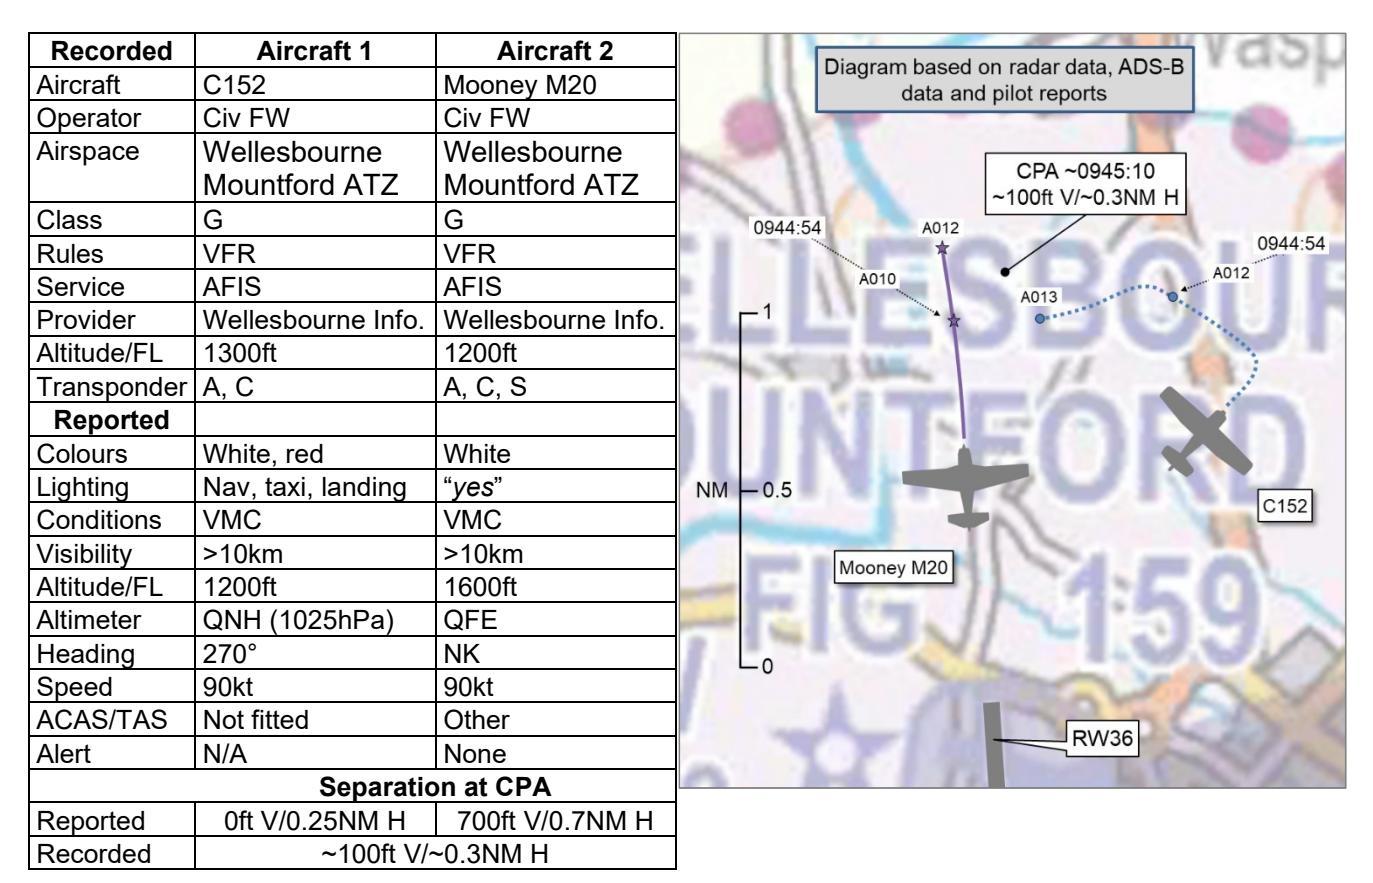
THE C152 PILOT reports that, after departure, and then following the noise abatement procedure from RW36, they were maintaining a crosswind heading of 270° at an altitude 1200ft AMSL. The operating pilot was a student under instruction.

They first saw the other aircraft climbing through their level (approximately 50ft higher) in their 11 o'clock position, tracking to the north at a range of approximately 200m. The risk was high, but the bearing was not constant, and it passed ahead of their position at a range of 100m. They were confident that the aircraft was going to miss, therefore took no avoiding action.

The conflicting aircraft had departed after them [and the pilot of the C152 opines that] the confliction was due to the other aircraft not following the noise abatement procedure (after departure, turn onto heading 030° and climb to 1000ft). They recall that an aircraft had received a clearance to enter RW36, and a departure clearance shortly after [the C152 pilot] had departed. They do not recall any other aircraft in the ATZ, therefore presume that that was the conflicting aircraft.
