AIRPROX REPORT No 2023257

Date: 25 Nov 2023 Time: 1029Z Position: 5120N 00018E Location: 2NM SE Brands Hatch

PART A: SUMMARY OF INFORMATION REPORTED TO UKAB

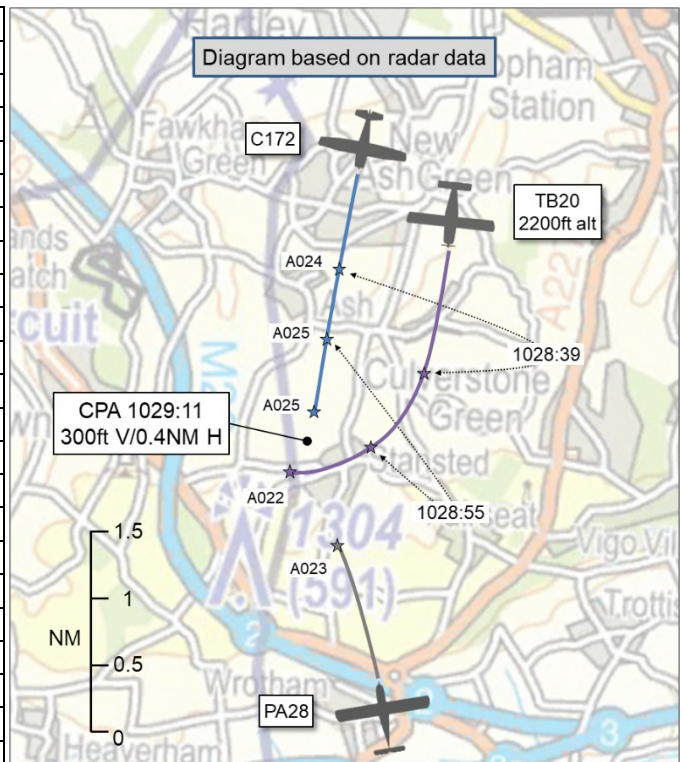
An analysis of the NATS radar replay was undertaken. Both aircraft could be positively identified from Mode S data (see Figure 4). The separation between the C172 and TB20 was observed to have been 0.5NM at 1029:07. The separation decreased to 0.4NM on the next radar sweep (Figure 5) and this was assessed to have been CPA. The diagram was constructed and the CPA determined from the radar data.
