**AIRPROX REPORT No 2024007**

Date: 16 Jan 2024 Time: 1502Z Position: 5318N 00249W Location: 1NM SW of Hale Lighthouse

**PART A: SUMMARY OF INFORMATION REPORTED TO UKAB**

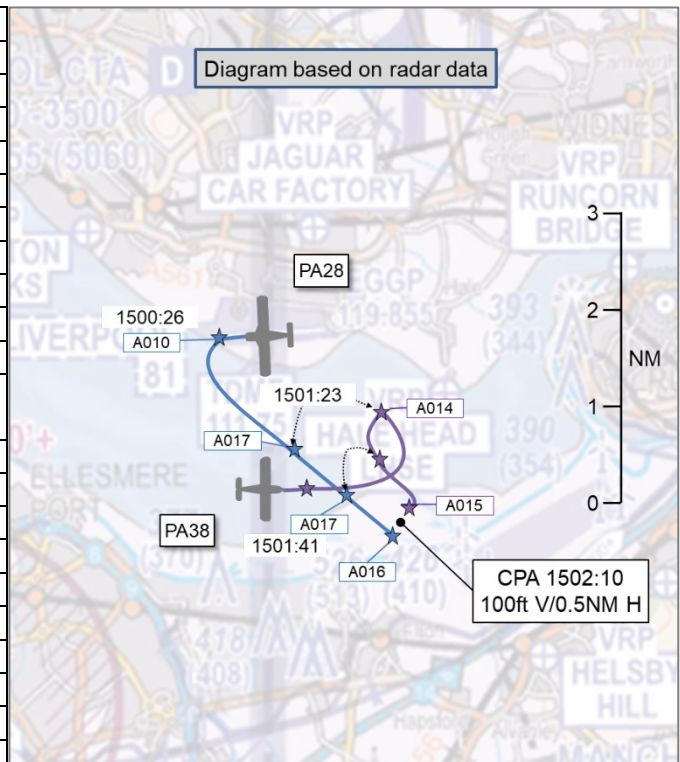
Recorded	Aircraft 1	Aircraft 2
Aircraft	PA28	PA38
Operator	Civ FW	Civ FW
Airspace	Liverpool CTR	Liverpool CTR
Class	D	D
Rules	VFR	VFR
Service	ACS	ACS
Provider	Liverpool Tower	Liverpool Tower
Altitude/FL	1600ft	1500ft
Transponder	A, C, S	A, C, S
<b>Reported</b>		
Colours	White with yellow & red stripe	White with red & yellow stripe
Lighting	Beacon	NR
Conditions	VMC	VMC
Visibility	>10km	>10km
Altitude/FL	1300ft	1100ft
Altimeter	QNH (1002hPa)	QNH (1002hPa)
Heading	120°	240°
Speed	140kt	90kt
ACAS/TAS	SkyEcho	SkyEcho
Alert	None	None
<b>Separation at CPA</b>		
Reported	0ft V/0.1NM H	200ft V/0.25NM H
Recorded	100ft V/0.5NM H
