AIRPROX REPORT No 2024039

Date: 25 Mar 2024 Time: 1225Z Position: 5139N 00033W Location: 1NM NE St. Giles VRP

PART A: SUMMARY OF INFORMATION REPORTED TO UKAB

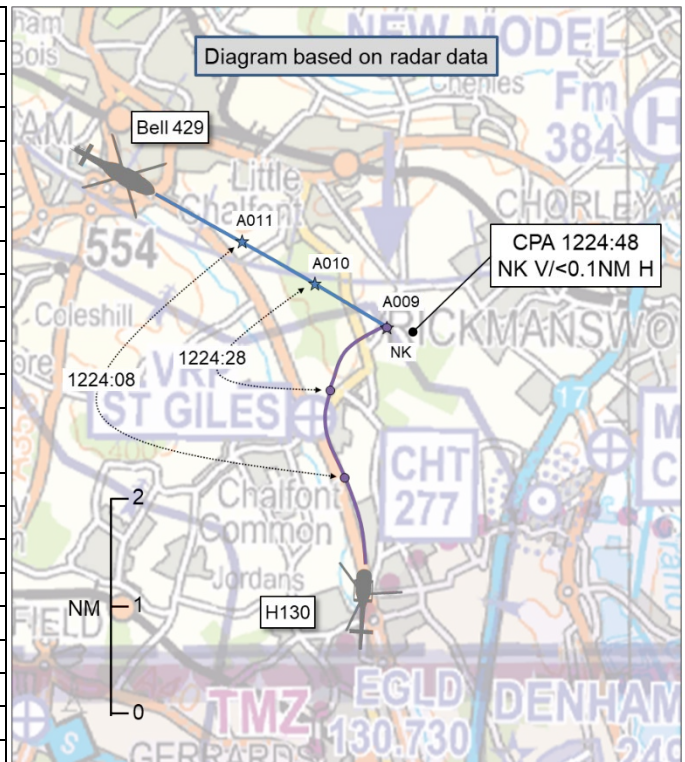
THE BELL 429 PILOT reports that they were transiting to Denham for a possible role-kit fault investigation. When approaching Maple Cross VRP, joining Denham right-base for RW24, an aircraft was seen in the 3 o'clock position extremely close to their aircraft. Almost immediately, the other aircraft passed directly through their overhead and out to the 9 o'clock position. The Observer, seated in the rear-left seat, saw the aircraft as it became visible in the 9 o'clock. No TCAS or [EC device] information on the other aircraft was displayed before or afterwards.

THE H130 PILOT reports that [this was] a very serious and scary mid-air near-miss incident that occurred shortly after departure. They had just left Denham's frequency without yet making contact with another unit. They were flying on an approximate heading of 080° and at an altitude of about 1100ft AMSL, positioned roughly 2NM north-east of St. Giles VRP. A helicopter, [Bell 429 callsign], crossed their flightpath from left-to-right at a 90° angle, passing just below them. This event was totally unforeseen as the helicopter emerged from a blind spot, not visible until the moment it was directly beneath them, before continuing its path to the right and disappearing from view.
