AIRPROX REPORT No 2024282

Date: 06 Nov 2024 Time: 1302Z Position: 5711N 00200W Location: 3NM E Bridge of Don

PART A: SUMMARY OF INFORMATION REPORTED TO UKAB

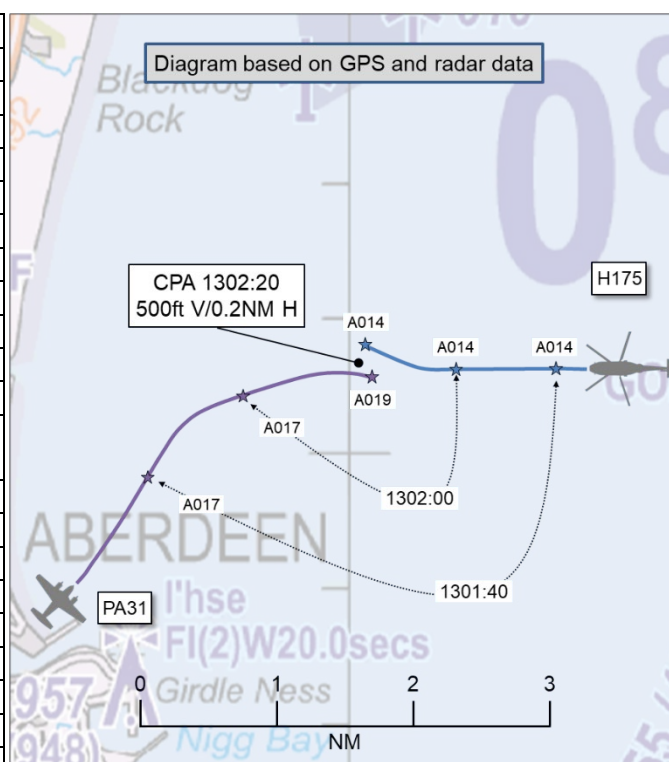
Recorded	Aircraft 1	Aircraft 2
Aircraft	H175	PA31
Operator	Civ Comm	Civ Comm
Airspace	Aberdeen CTR	Aberdeen CTR
Class	D	D
Rules	VFR	VFR
Service	ACS	Radar Control
Provider	Aberdeen Tower	Aberdeen Radar
Altitude/FL	1400ft	1900ft
Transponder	A, C, S+	A, C, S
Reported		
Colours	Red, white, blue	White, orange
Lighting	Anti-col, position, landing	Strobes, beacon
Conditions	VMC	VMC
Visibility	>10km	>10km
Altitude/FL	1500ft	1500ft
Altimeter	QNH	QFE
Heading	270°	NK
Speed	130kt	160kt
ACAS/TAS	TCAS II	TAS
Alert	RA	None
Separation at CPA		
Reported	0ft V/<1NM H	0ft V/0.5NM H
Recorded	500ft V/0.2NM H
