**AIRPROX REPORT No 2025005**

Date: 25 Jan 2025 Time: 1535Z Position: 5214N 00253W Location: Shobdon

**PART A: SUMMARY OF INFORMATION REPORTED TO UKAB**

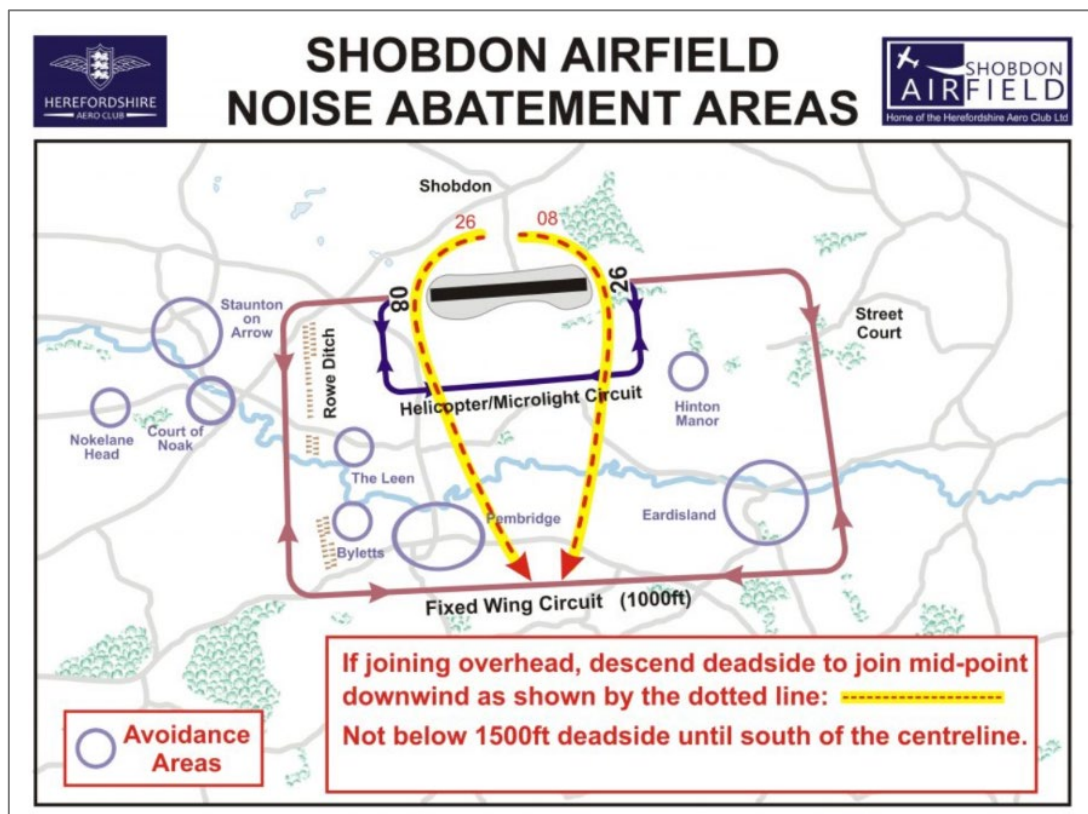
Figure 1 – Noise abatement areas at Shobdon

The Shobdon website provided the following diagram for circuit information and noise abatement areas:
