AIRPROX REPORT No 2025007

Date: 29 Jan 2025 Time: 1508Z Position: 5219N 00048W Location: Sywell Airfield

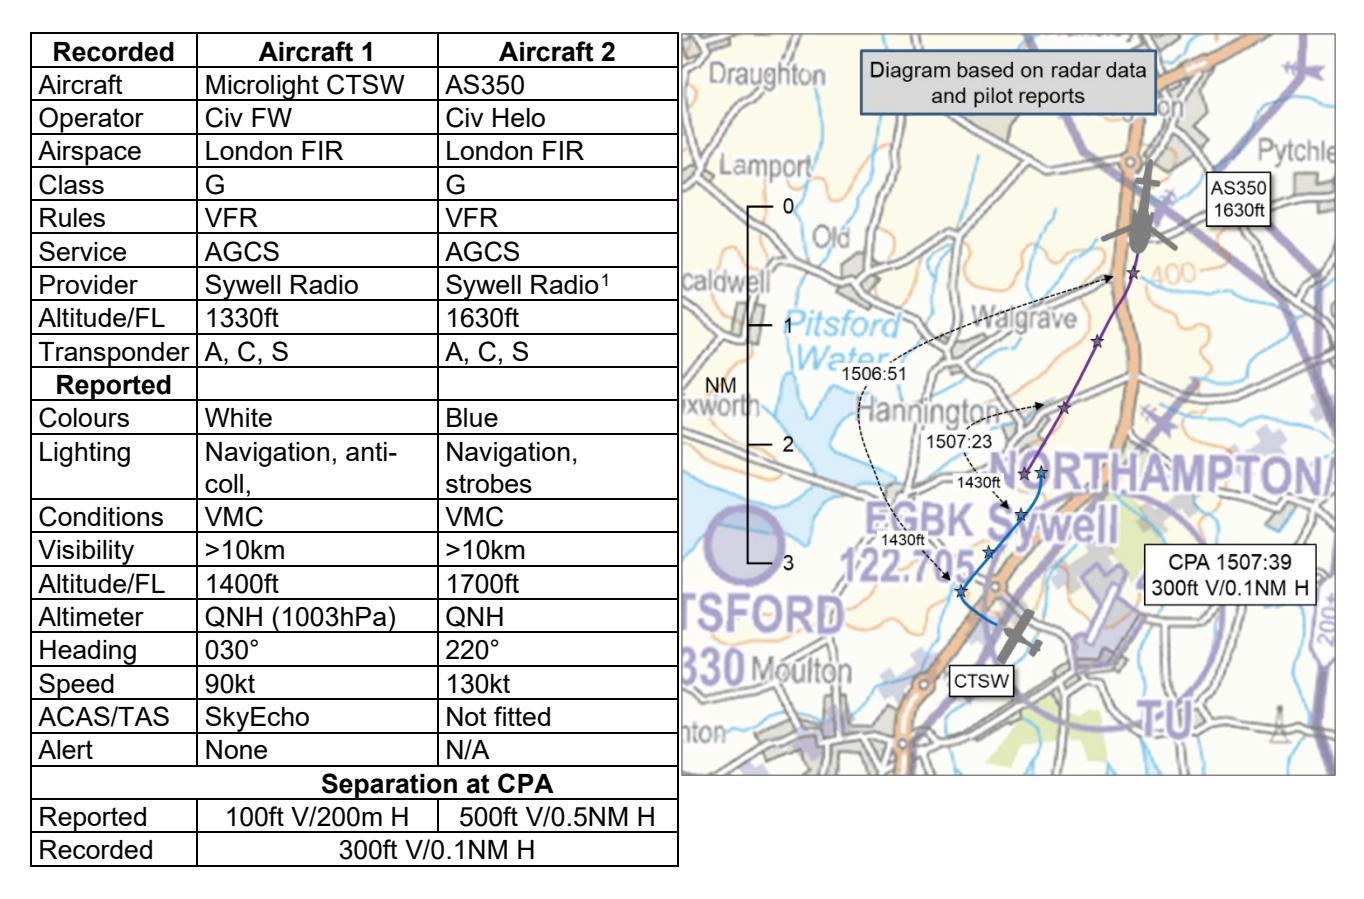
THE CTSW PILOT reports that they had returned to Sywell and joined the circuit for two touch-andgoes followed by a full stop landing. The first two circuits were completed uneventfully. Whilst on downwind of the final circuit, they had heard the pilot of the AS350 call Sywell Radio reporting a position to the west and at 1600ft asking for any traffic in the vicinity. The Radio operator advised both rotary (left-hand) and fixed-wing (right-hand) circuits active for RW21. At that time, the microlight pilot was at the midpoint of the downwind leg, and sighted the helicopter at a similar altitude, routeing along the downwind leg in the opposite direction, closing rapidly but slightly off to their left side. The microlight pilot did not take any avoiding action as their relative bearings combined with their slightly offset tracks would not have resulted in a collision. There had been another aircraft on downwind behind them, the pilot of which also sighted the traffic and expressed surprise at the routeing chosen by the AS350 pilot.

THE SYWELL RADIO OPERATOR reports that they had been on the radio that day and had reported no traffic to affect [the CTSW] as they had been inbound and there was nobody else on frequency. As

the CTSW came around the circuit, the helicopter had flown straight through, at circuit height and without making any radio calls, including blind calls [they recalled].
