AIRPROX REPORT No 2025010

Date: 31 Jan 2025 Time: 1307Z Position: 5247N 00240W Location: Shawbury

PART A: SUMMARY OF INFORMATION REPORTED TO UKAB

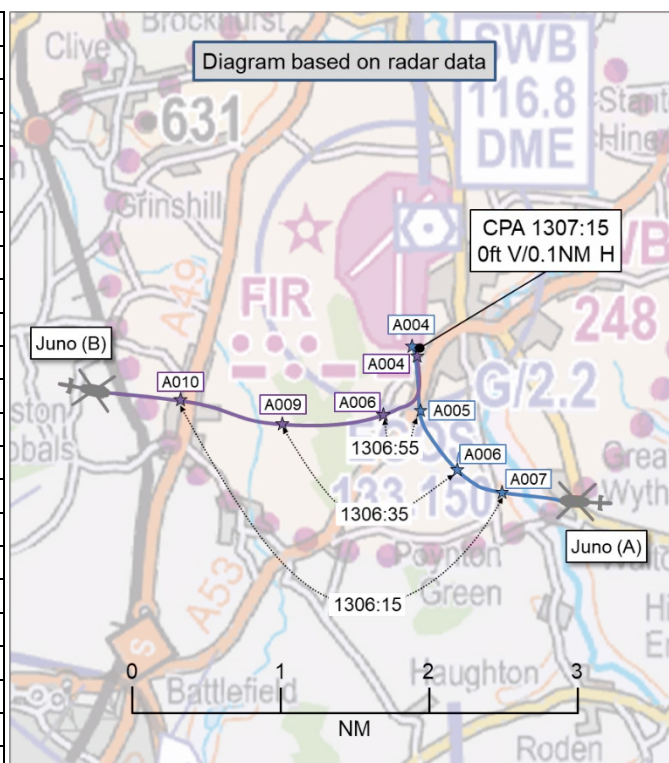
Recorded	Aircraft 1	Aircraft 2
Aircraft	Juno(A)	Juno(B)
Operator	HQ Air (Trg)	HQ Air (Trg)
Airspace	Shawbury ATZ	Shawbury ATZ
Class	G	G
Rules	VFR	VFR
Service	ACS	ACS
Provider	Shawbury Tower	Shawbury Tower
Altitude/FL	400ft	400ft
Transponder	A, C, S	A, C, S
Reported		
Colours	Black and yellow	Black and yellow
Lighting	Landing nav HISL	Lndg nav anti-colls
Conditions	VMC	VMC
Visibility	5-10km	5-10km
Altitude/FL	50ft	100ft
Altimeter	QNH (1024hPa)	QNH (1023hPa)
Heading	NR	NR
Speed	65kt	65kt
ACAS/TAS	TAS	TAS
Alert	None	None ¹
Separation at CPA		
Reported	50ft V/50m H	50ft V/45m H
Recorded	0ft V/0.1NM H
