AIRPROX REPORT No 2025011

Date: 05 Feb 2025 Time: 1344Z Position: 5231N 00253W Location: Long Mynd

PART A: SUMMARY OF INFORMATION REPORTED TO UKAB

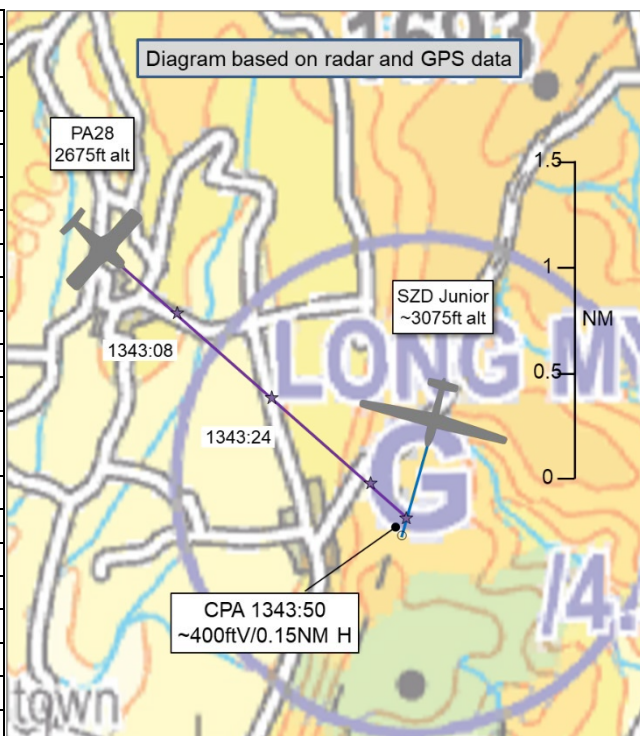
Recorded	Aircraft 1	Aircraft 2
Aircraft	SZD-51-1 Junior	PA28
Operator	Civ Gld	Civ FW
Airspace	London FIR	London FIR
Class	G	G
Rules	VFR	VFR
Service	Listening Out	Basic
Provider	Long Mynd	Shawbury Zone
Altitude/FL	~3075ft	2675ft
Transponder	Not fitted	A, C, S
Reported		
Colours	White	Orange, white
Lighting	Nil	Ldg, taxi, nav, bcn, anti-colls, strobes
Conditions	VMC	VMC
Visibility	>10km	>10km
Altitude/FL	~2500ft	2700ft
Altimeter	QFE	QNH (1038hPa)
Heading	200°	135°
Speed	67kt	95kt
ACAS/TAS	FLARM	PilotAware
Alert	None	None
Separation at CPA		
Reported	Not seen	Not seen
Recorded	~400ft V/0.15NM H
