**AIRPROX REPORT No 2025012**

Date: 05 Feb 2025 Time: 1231Z Position: 5045N 00050W Location: 7NM SSW Goodwood

**PART A: SUMMARY OF INFORMATION REPORTED TO UKAB**

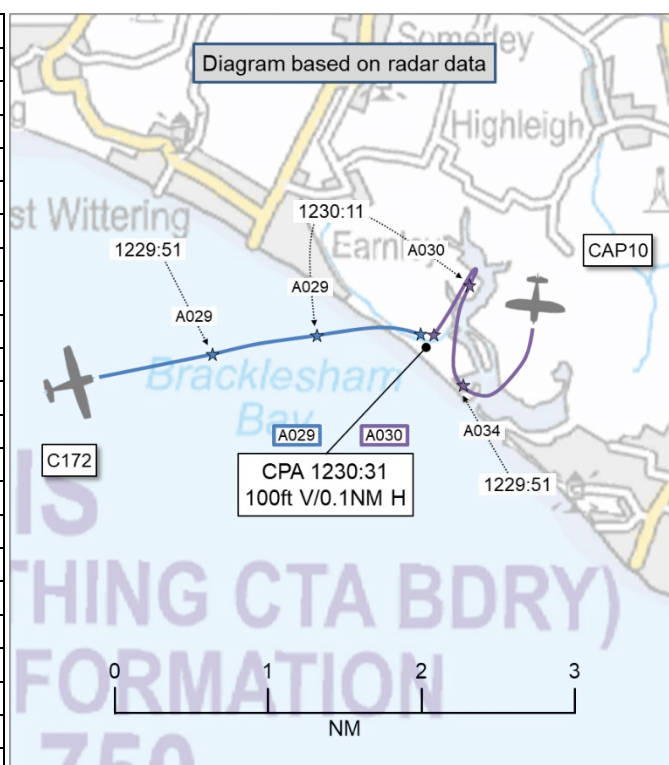
Recorded	Aircraft 1	Aircraft 2
Aircraft	C172	CAP10
Operator	Civ FW	Civ FW
Airspace	London FIR	London FIR
Class	G	G
Rules	VFR	VFR
Service	Listening out	Listening out
Provider	Bembridge Traffic	Goodwood Info.
Altitude/FL	2900ft	3000ft
Transponder	A, C, S	A, C, S
Reported		
Colours	White, red, blue	Red, white
Lighting	Landing, taxi, bcn	Strobes
Conditions	VMC	VMC
Visibility	NR	>10km
Altitude/FL	2900ft	"various"
Altimeter	QNH (1038hPa)	QNH
Heading	080°	"various"
Speed	110kt	"various"
ACAS/TAS	SkyEcho	Not fitted
Alert	None	N/A
Separation at CPA		
Reported	200ft V/200m H	1000ft V/1NM H
Recorded	100ft V/0.1NM H

**THE C172 PILOT** reports that their planned route was along the coast at 2900ft on 1038hPa QNH. Nearing the coastline at Bracklesham Bay, an aircraft was noticed in the 11 o'clock position. It was about 200-300ft higher than them and was tracking approximately north-west. Its nose was high and they considered that its pilot would make an aerobatic manoeuvre with a possible course reversal that would place them into conflict with the [C172]. The pilot did make a course reversal and the aircraft was then tracking across their path and moved from their left-to-right in an approximately south-westerly track. [The pilot of the C172] altered heading to the left [they recall] by about 15° to direct their illuminated landing light at the aircraft. The aircraft passed in front of them, about 200ft above, at an approximate range of 200m.
