**AIRPROX REPORT No 2025013**

Date: 29 Jan 2025 Time: 1035Z Position: 5220N 00045W Location: Orlington, Northants

**PART A: SUMMARY OF INFORMATION REPORTED TO UKAB**

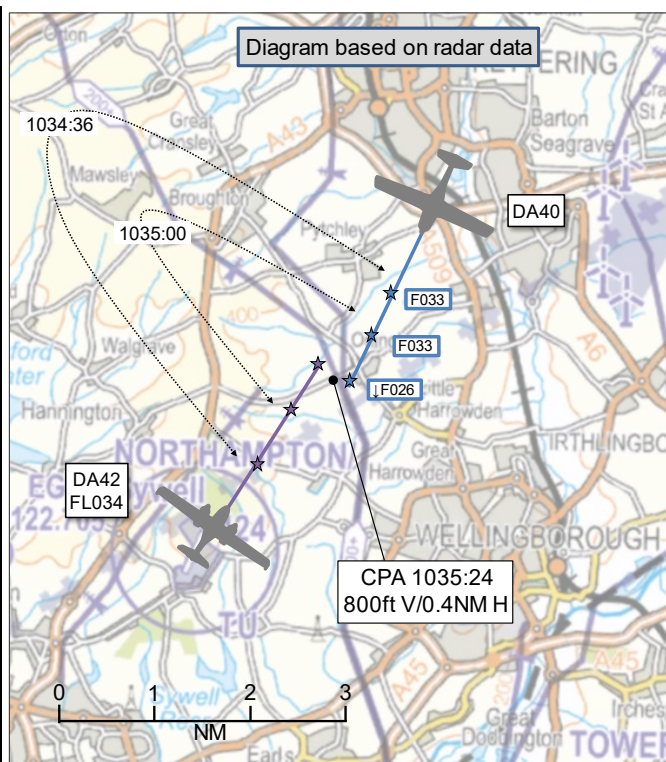
Recorded	Aircraft 1	Aircraft 2
Aircraft	DA40	DA42
Operator	Civ FW	Civ FW
Airspace	London FIR	London FIR
Class	G	G
Rules	VFR	VFR
Service	NK <sup>1</sup>	Basic
Provider	East Midlands	Wellesbourne
Altitude/FL	FL026	FL034
Transponder	A, C, S	A, C, S
Reported		
Colours	White	White
Lighting	Nav, Strobe, Landing, Taxi	'On'
Conditions	VMC	VMC
Visibility	>10km	>10km
Altitude/FL	2950ft	NK
Altimeter	QNH	QNH
Heading	~210°	NK
Speed	110kt	120kt
ACAS/TAS	TAS	Not fitted
Alert	Information	N/A
Separation at CPA		
Reported	Not Seen	Not Seen
Recorded	800ft V/0.4NM H
