AIRPROX REPORT No 2025017

Date: 18 Feb 2025 Time: 1505Z Position: 5122N 00101W Location: 6.5NM WNW Blackbushe

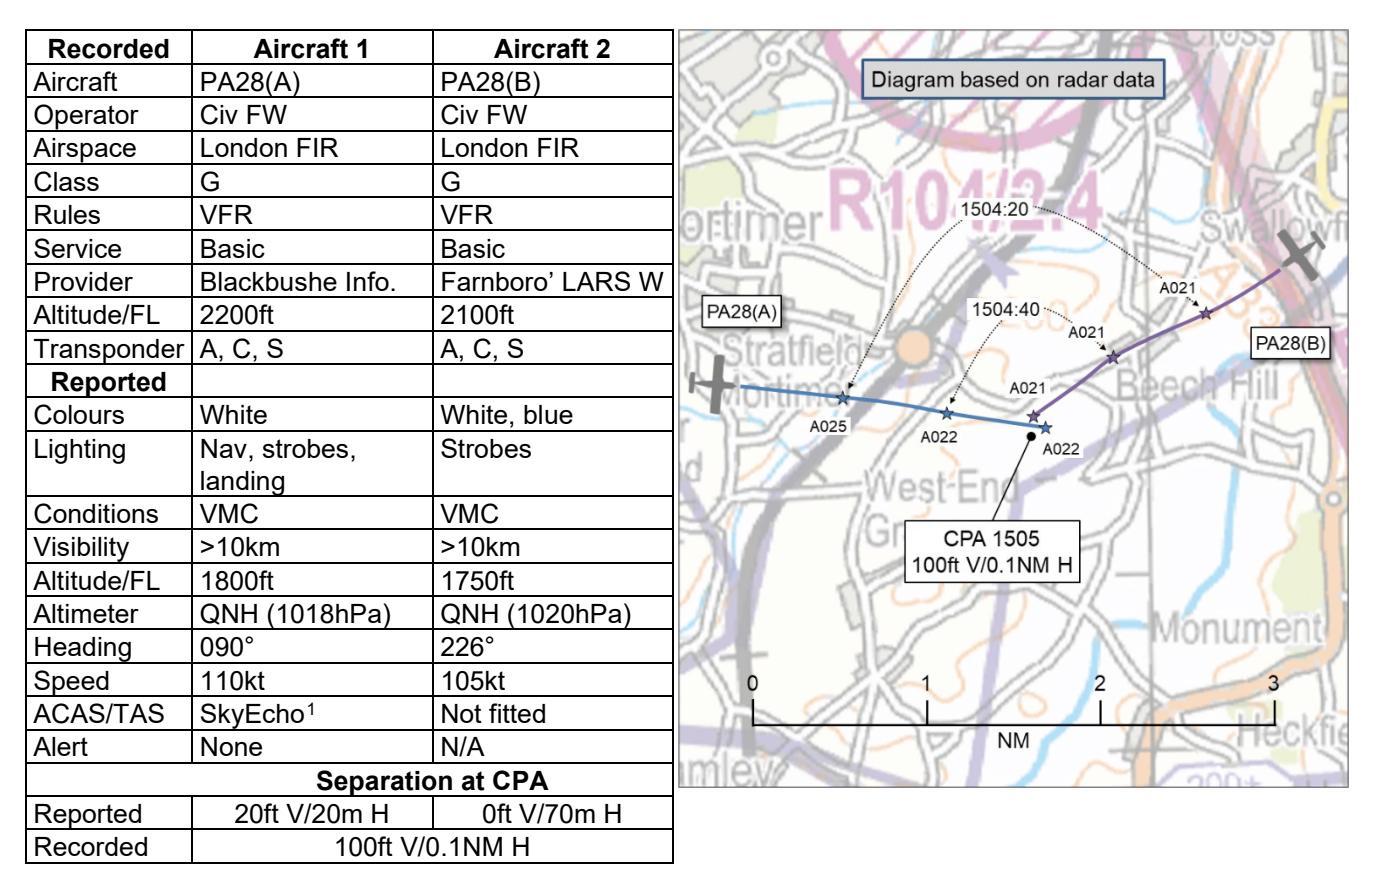
An analysis of the NATS radar replay was undertaken and both aircraft could be positively identified from Mode S data. Both aircraft were observed by reference to ADS-B data sources. The diagram was constructed and the separation determined from the radar data.
