AIRPROX REPORT No 2025018

Date: 22 Feb 2025 Time: ~1534Z Position: 5244N 00058W Location: 3NM WSW Melton Mowbray

PART A: SUMMARY OF INFORMATION REPORTED TO UKAB

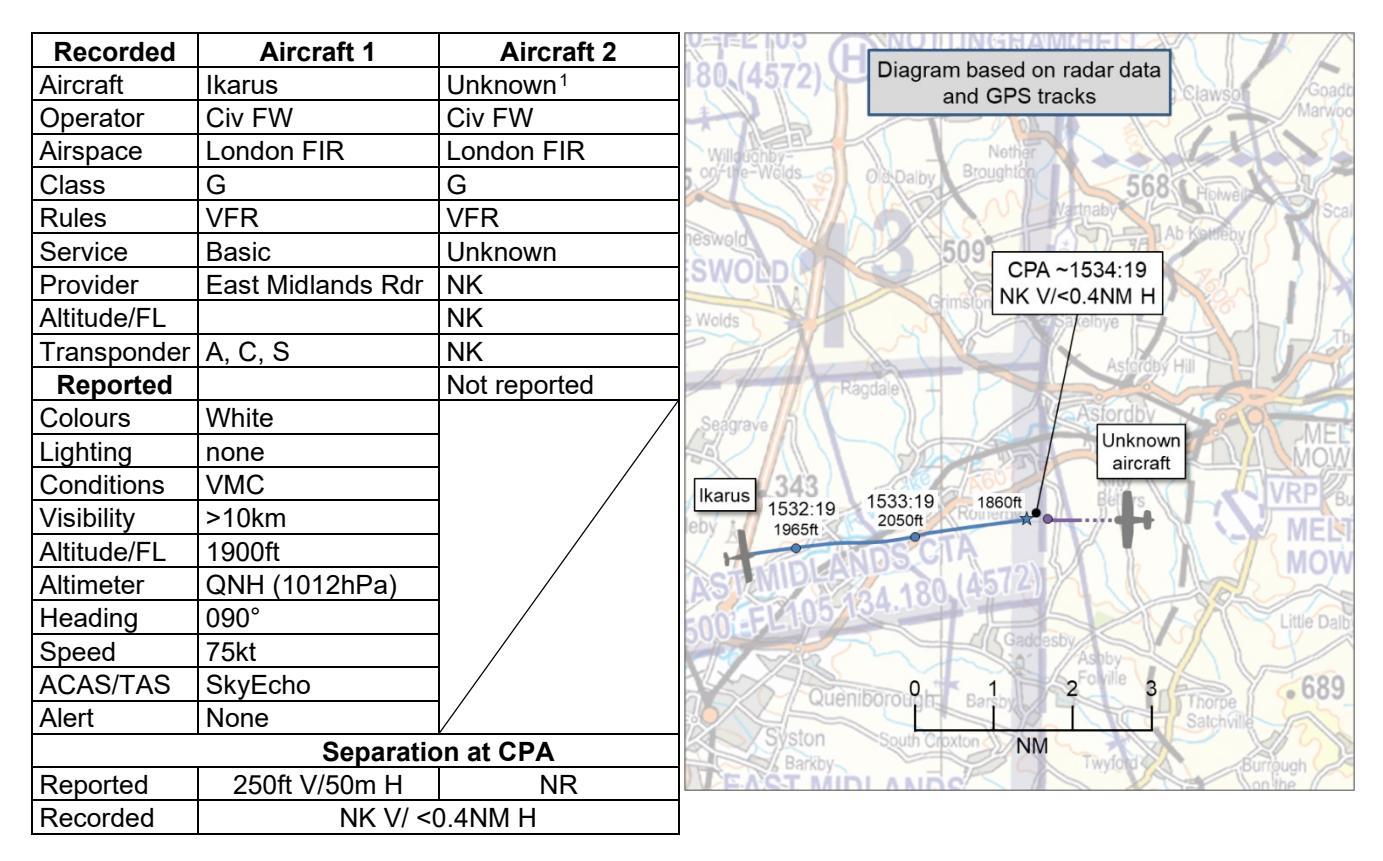
THE IKARUS PILOT reports they were routeing underneath East Midlands airspace from [departure to destination] in a steady cruise around 1900ft on Basic Service. They suddenly spotted an aircraft slightly high and to the right, but largely on a reciprocal heading. They descended to increase separation and informed East Midlands Radar of an Airprox as they were unsure if they could report via radio to them. [East Midlands ATC] advised logging the Airprox online. They were conscious of the low sun and them being in the blind spot under the cowling of the other aircraft. The Ikarus pilot further reported that they had first sighted the unknown aircraft at approximately ½NM.
