**AIRPROX REPORT No 2025023**

Date: 01 Mar 2025 Time: 1152Z Position: 5053N 00129W Location: 6NM SW Southampton

**PART A: SUMMARY OF INFORMATION REPORTED TO UKAB**

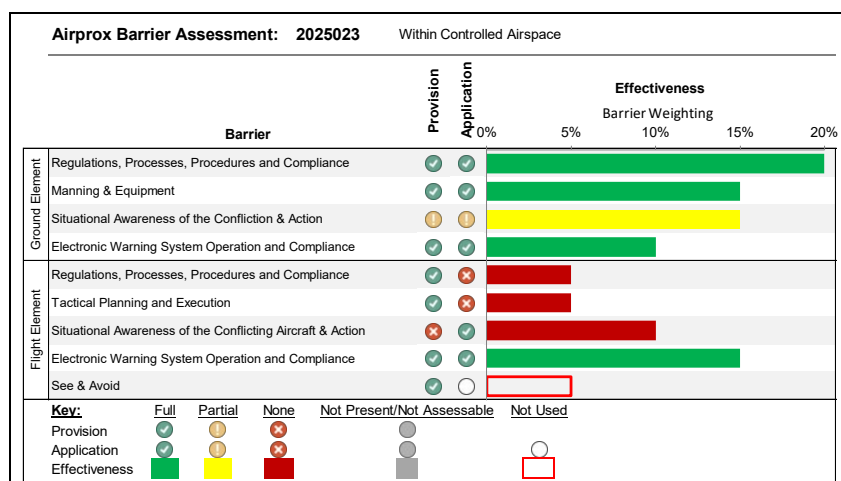
**Situational Awareness of the Conflicting Aircraft and Action** were assessed as **ineffective** because the G280 pilot had not been monitoring the frequency sufficiently in order to have realised that the clearance to climb had not been for them.

**See and Avoid** were assessed as **not used** because ATC took action to regain standard separation before see and avoid became necessary.
