AIRPROX REPORT No 2025026

Date: 07 Mar 2025 Time: 1801Z Position: 5143N 00011E Location: 1.3NM east of North Weald

PART A: SUMMARY OF INFORMATION REPORTED TO UKAB

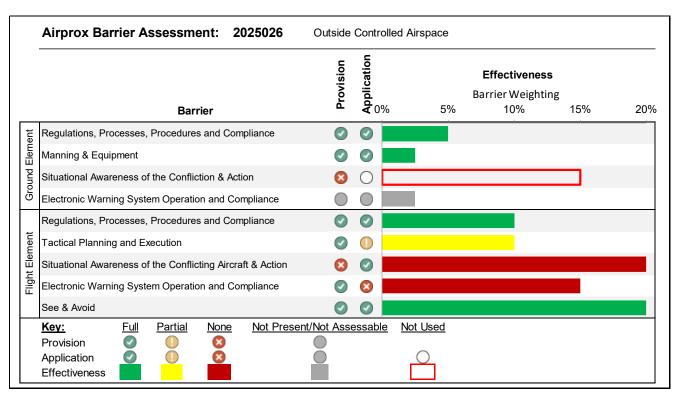
Situational Awareness of the Conflicting Aircraft and Action were assessed as ineffective because neither pilot had any situational awareness of the presence of the other aircraft.

Electronic Warning System Operation and Compliance were assessed as **ineffective** because although the AW109 and the PA28 carried compatible electronic conspicuity equipment, neither pilot reported having received an alert.
