**AIRPROX REPORT No 2025029**

Date: 16 Mar 2025 Time: ~1336Z Position: 5122N 00102W Location: SW of Mortimer

**PART A: SUMMARY OF INFORMATION REPORTED TO UKAB**

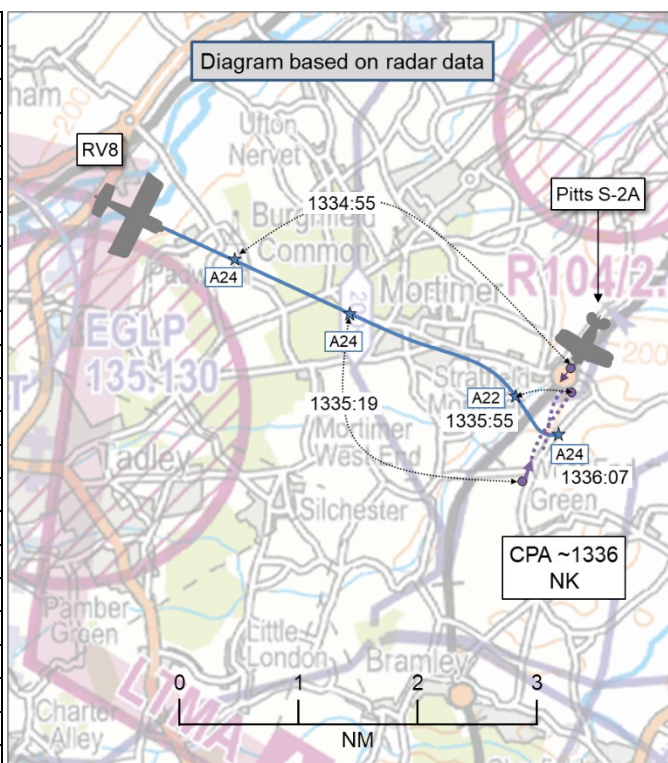
**THE RV8 PILOT** reports that they were inbound to Blackbushe, in a slow descent from 3000ft, passing 2100ft, heading 110°. They observed an aircraft in their 11 o'clock position in a spinning manoeuvre descending through their level approximately 1-2NM away. They observed the aircraft exit the spin below them in their 11-12 o'clock position approximately ½NM away, on a track of approximately 160°. They saw the aircraft begin to pitch up, so they made a hard turn to the left to avoid it and commenced a climb. As they rolled out of the avoiding turn they looked over their right shoulder to see the aircraft, which they believed to be a Pitts Special or similar, pass 100-200m away in a vertical climb in their 5 o'clock position. They had ADS-B [electronic conspicuity equipment] fitted and nothing was shown on their display, and the aircraft was not in contact with [the Blackbushe] AFISO or Farnborough LARS. Had they not seen the aircraft and initiated avoiding action they believed a collision would have occurred.

The pilot assessed the risk of collision as 'High'.
