AIRPROX REPORT No 2025032

Date: 11 Mar 2025 Time: 1038Z Position: 5158N 00201W Location: 3.5NM NE Cheltenham

PART A: SUMMARY OF INFORMATION REPORTED TO UKAB

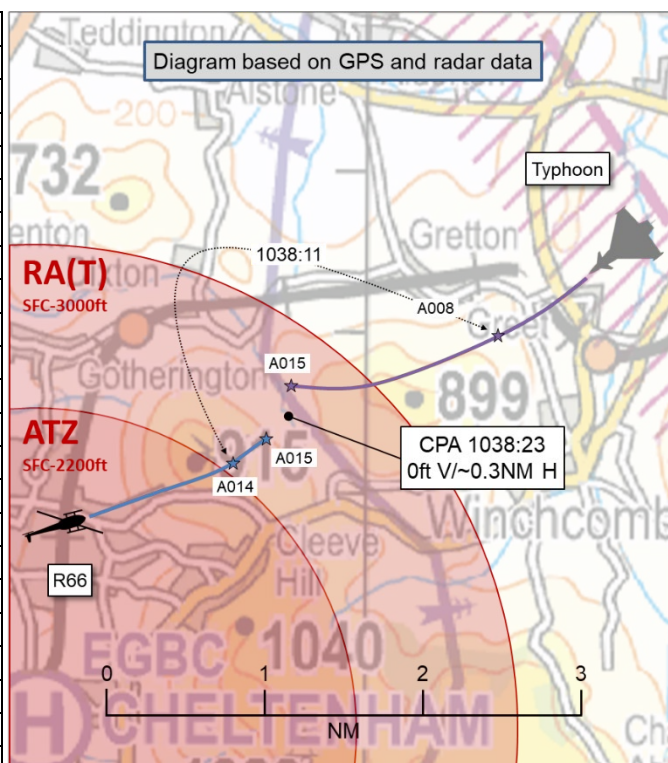
Recorded	Aircraft 1	Aircraft 2
Aircraft	R66	Typhoon
Operator	Civ Comm	HQ Air (Ops)
Airspace	RA(T)	RA(T)
Class	G	G
Rules	VFR	VFR
Service	ACS	Listening Out
Provider	Cheltenham Tower	Low-level common
Altitude/FL	1500ft	1500ft
Transponder	A, C, S	A, C, S
Reported		
Colours	Black	Grey
Lighting	Nav, strobe, ldg.	'Standard'
Conditions	VMC	VMC
Visibility	>10km	>10km
Altitude/FL	NK	250ft MSD
Altimeter	QNH	NR
Heading	NK	NR
Speed	NK	420kt
ACAS/TAS	Not fitted	Not fitted
Separation at CPA		
Reported	250ft V/250m H	1000ft V/1NM H
Recorded	0ft V/~0.3NM H

THE R66 PILOT reports that they had just lifted after dropping people off at Cheltenham and were making their way out of the restricted airspace to the north-east towards Dixton Hill. A fast jet (believed to be a Typhoon) crossed in front of them. It was low-level, quite fast, right-to-left, just in front and below them and inside the restricted area. They then heard another pilot make an urgent call on the radio warning the controller. After that, [the pilot of the R66] heard another helicopter pilot mention that they had seen the Typhoon out to the north. At that point, the controller made a broadcast warning all the pilots in the area that a Typhoon was in the vicinity and not on frequency. The pilot of the R66 described that they took avoiding action by continuing their climb.

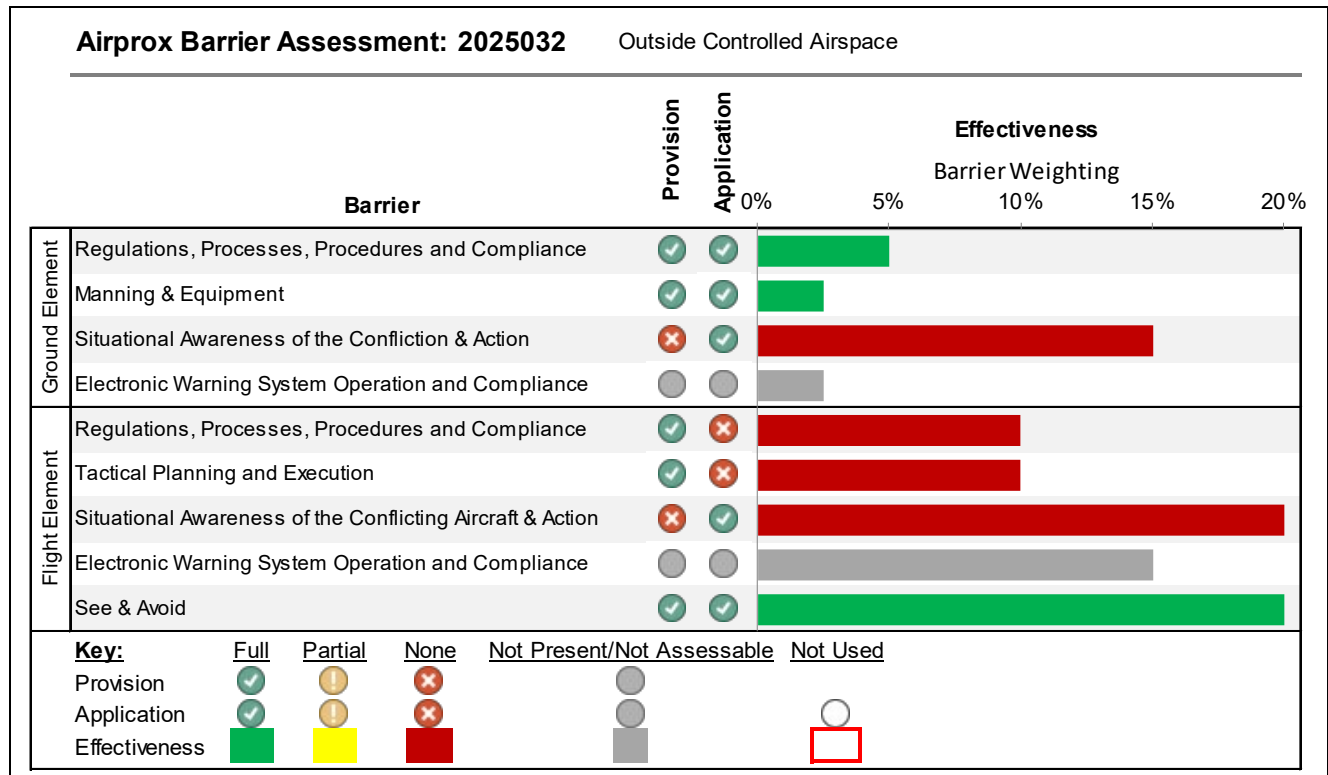
Tactical Planning and Execution was assessed as **ineffective** because the planning resources used by the pilot of the Typhoon had not provided information pertaining to the RA(T).

Situational Awareness of the Conflicting Aircraft and Action were assessed as **ineffective** because the pilot of the R66 had not had situational awareness of the presence of the Typhoon until visually acquired.
