AIRPROX REPORT No 2025034

Date: 21 Mar 2025 Time: 1519Z Position: 5144N 00010E Location: IVO North Weald

PART A: SUMMARY OF INFORMATION REPORTED TO UKAB

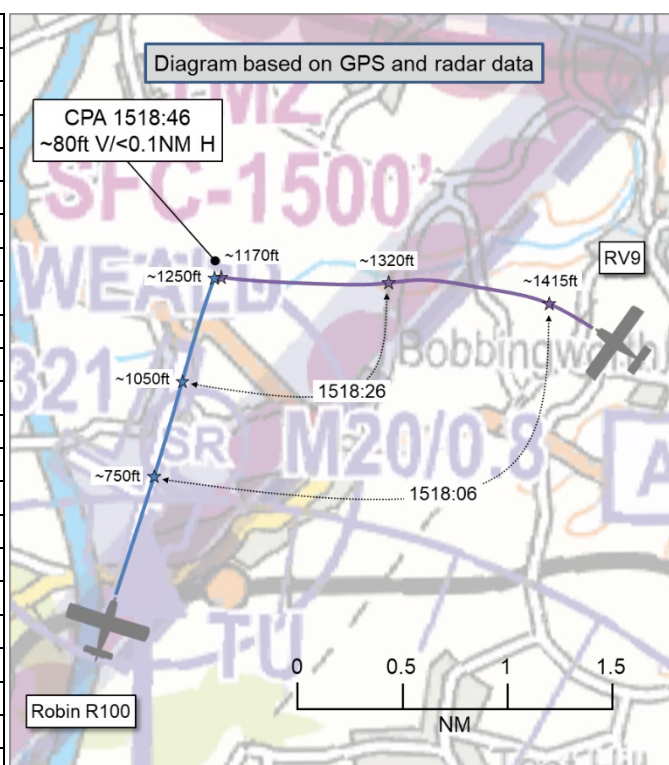
Recorded	Aircraft 1	Aircraft 2
Aircraft	Robin R100	RV9
Operator	Civ FW	Civ FW
Airspace	London FIR	London FIR
Class	G	G
Rules	VFR	VFR
Service	AGCS	AGCS
Provider	North Weald Radio	North Weald Radio
Altitude/FL	~1250ft	~1170ft
Transponder	A, C, S	A, C, S
Reported		
Colours	White, red	White, grey
Lighting	Strobes, landing	Strobes
Conditions	VMC	VMC
Visibility	>10km	>10km
Altitude/FL	1200ft	1200ft
Altimeter	QNH	QNH
Heading	020°	275°
Speed	80kt	120kt
ACAS/TAS	Not fitted	PilotAware
Alert	N/A	Information
Separation at CPA		
Reported	50ft V/0m H	100ft V/NR H
Recorded	~80ft V/<0.1NM H

THE ROBIN R100 PILOT reports that [they had conducted] a go-around on RW02LH at North Weald airfield due to an occupied runway. They made the go-around decision early, which resulted in them being at 1200ft (circuit height) by the upwind end of the runway. They maintained 80kt (approximately) with flap-one and followed the published circuit. Just before the crosswind turn was to be made, their passenger shouted “*Traffic, right!*” and they were alerted to the RV9 on a collision course, 90° to their right. The [pilot of the RV9] had called inbound some time before but they are not sure of the timings.

No sooner had their passenger alerted them than the aircraft passed less than 50ft below. Their instant reaction, and possibly startled reaction, was a pitch-up action. This had no effect at that stage as the RV9 had passed by as they saw it. They were close enough that they could make out the heads of both pilots as they passed.
