AIRPROX REPORT No 2025037

Date: 20 Mar 2025 Time: 1606Z Position: 5327N 00252W Location: Croxteth

PART A: SUMMARY OF INFORMATION REPORTED TO UKAB

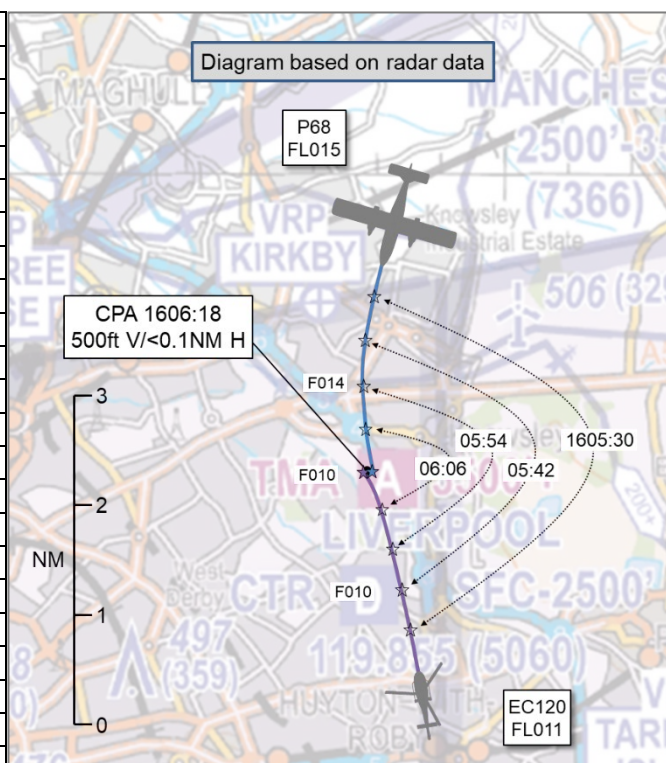
Recorded	Aircraft 1	Aircraft 2
Aircraft	P68	EC120
Operator	Civ Comm	Civ Comm
Airspace	Liverpool CTR	Liverpool CTR
Class	D	D
Rules	VFR	VFR
Service	Radar Control	Radar Control
Provider	Liverpool	Liverpool
Altitude/FL	FL015	FL010
Transponder	A, C, S	A, C, S
Reported		
Colours	White	Dark grey
Lighting	Beacon, nav	'yes'
Conditions	VMC	VMC
Visibility	>10km	NR
Altitude/FL	1500ft	~1000ft
Altimeter	QNH (1016hPa)	QNH (NK hPa)
Heading	180°	NK
Speed	120kt	~100kt
ACAS/TAS	SkyEcho	Not fitted
Alert	None	N/A
Separation at CPA		
Reported	250ft V/0m H	'hard to say'
Recorded	500ft V/<0.1NM H

THE P68 PILOT reports that, as they approached the Kirkby VRP to join at Liverpool, helicopter traffic was reported to them about 5NM south of Kirkby at 1200ft, heading north. They were unable to see the traffic so informed ATC they weren't visual. They believe the helicopter [pilot] reported visual with them. After being placed under Radar Control they then had another update on the traffic, 3.5NM south of their position, 400ft below. They were still unable to see the traffic but continued looking. Shortly after, they saw the helicopter pass directly below them with a clearance of what appeared to be 200-300ft. As they only saw the helicopter at the last minute no avoiding action was taken.

The Board agreed that the P68 pilot had probably been startled by the proximity of the EC120, due in part to their late sighting of it, and had perceived a lesser vertical separation than that shown on radar replay. An ATC member noted that although the P68 pilot had requested a 'non-standard' routeing, that request had been agreed to by ATC and that the provisions of CAP493 (MATS Part 1) Section 1 Chapter 5, paras 3.1 and 3.3 had applied, i.e. although the P68 pilot had requested a 'non-standard' routeing, ATC had still had a responsibility to prevent collisions and maintain a safe, orderly and expeditious flow of traffic. In the event, both pilots had been operating under VFR in Class D airspace, had been passed Traffic Information, the EC120 pilot had seen the P68 and the aircraft had been altitude separated by 500ft, Risk E. The following contributory factors were relevant:
