AIRPROX REPORT No 2025040

Date: 20 Mar 2025 Time: 1556Z Position: 5158N 00004W Location: 2NM NW Buntingford

PART A: SUMMARY OF INFORMATION REPORTED TO UKAB

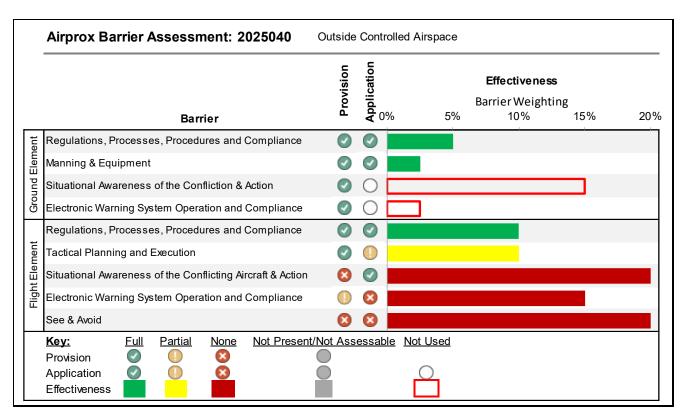
Electronic Warning System Operation and Compliance were assessed as **ineffective** because the TCAS fitted to the H145 would have been expected to have detected the Sprite but no alert was reported.

See and Avoid were assessed as **ineffective** because the pilot of the Sprite had not sighted the H145 and the pilot of the H145 had not sighted the Sprite in time to have taken effective avoiding action.
